Structural Alteration

554 Forest Avenue

EBC Case Study #1

STRUCTURAL CODE ANALYSIS

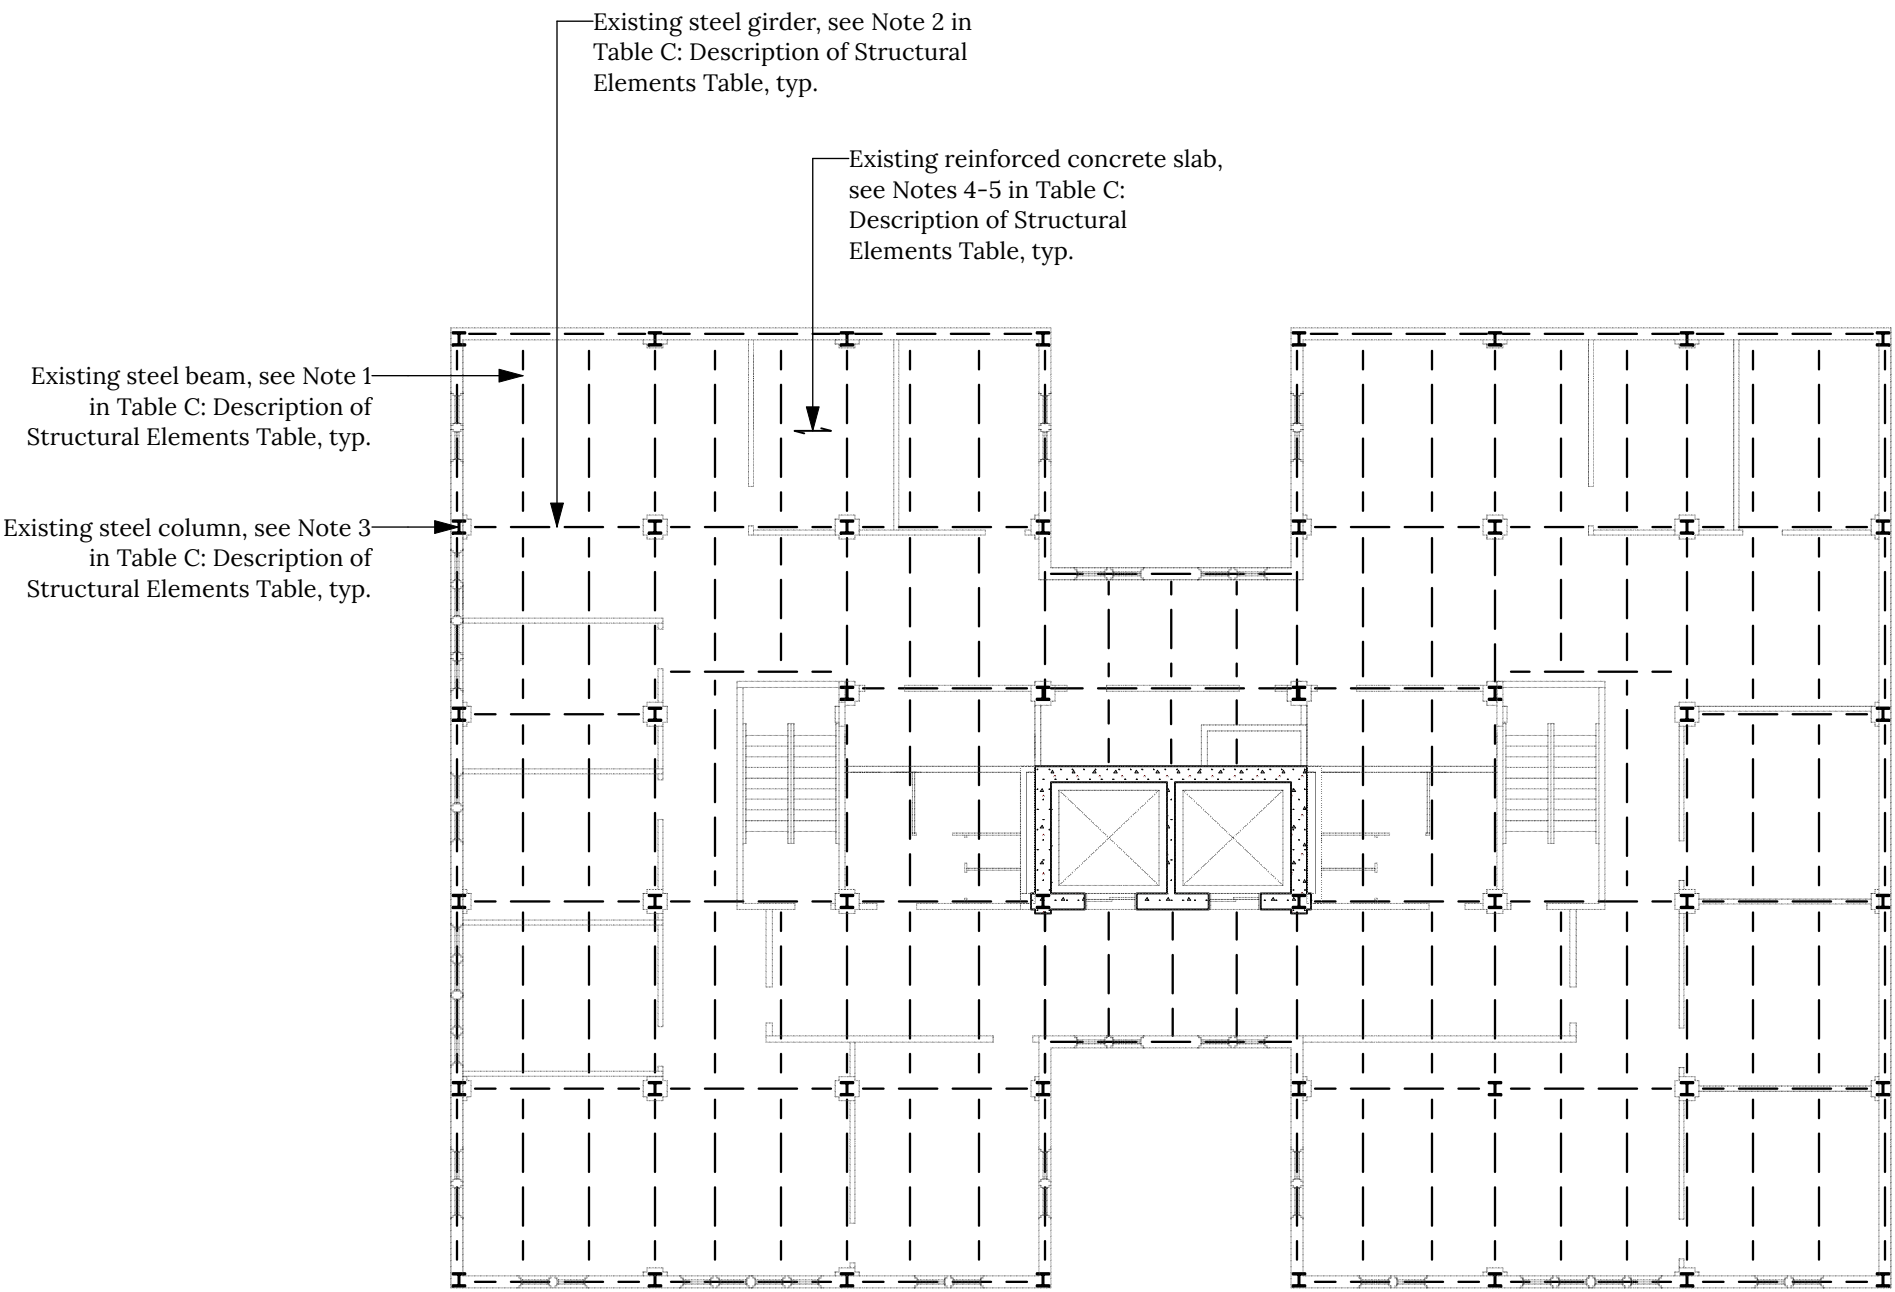
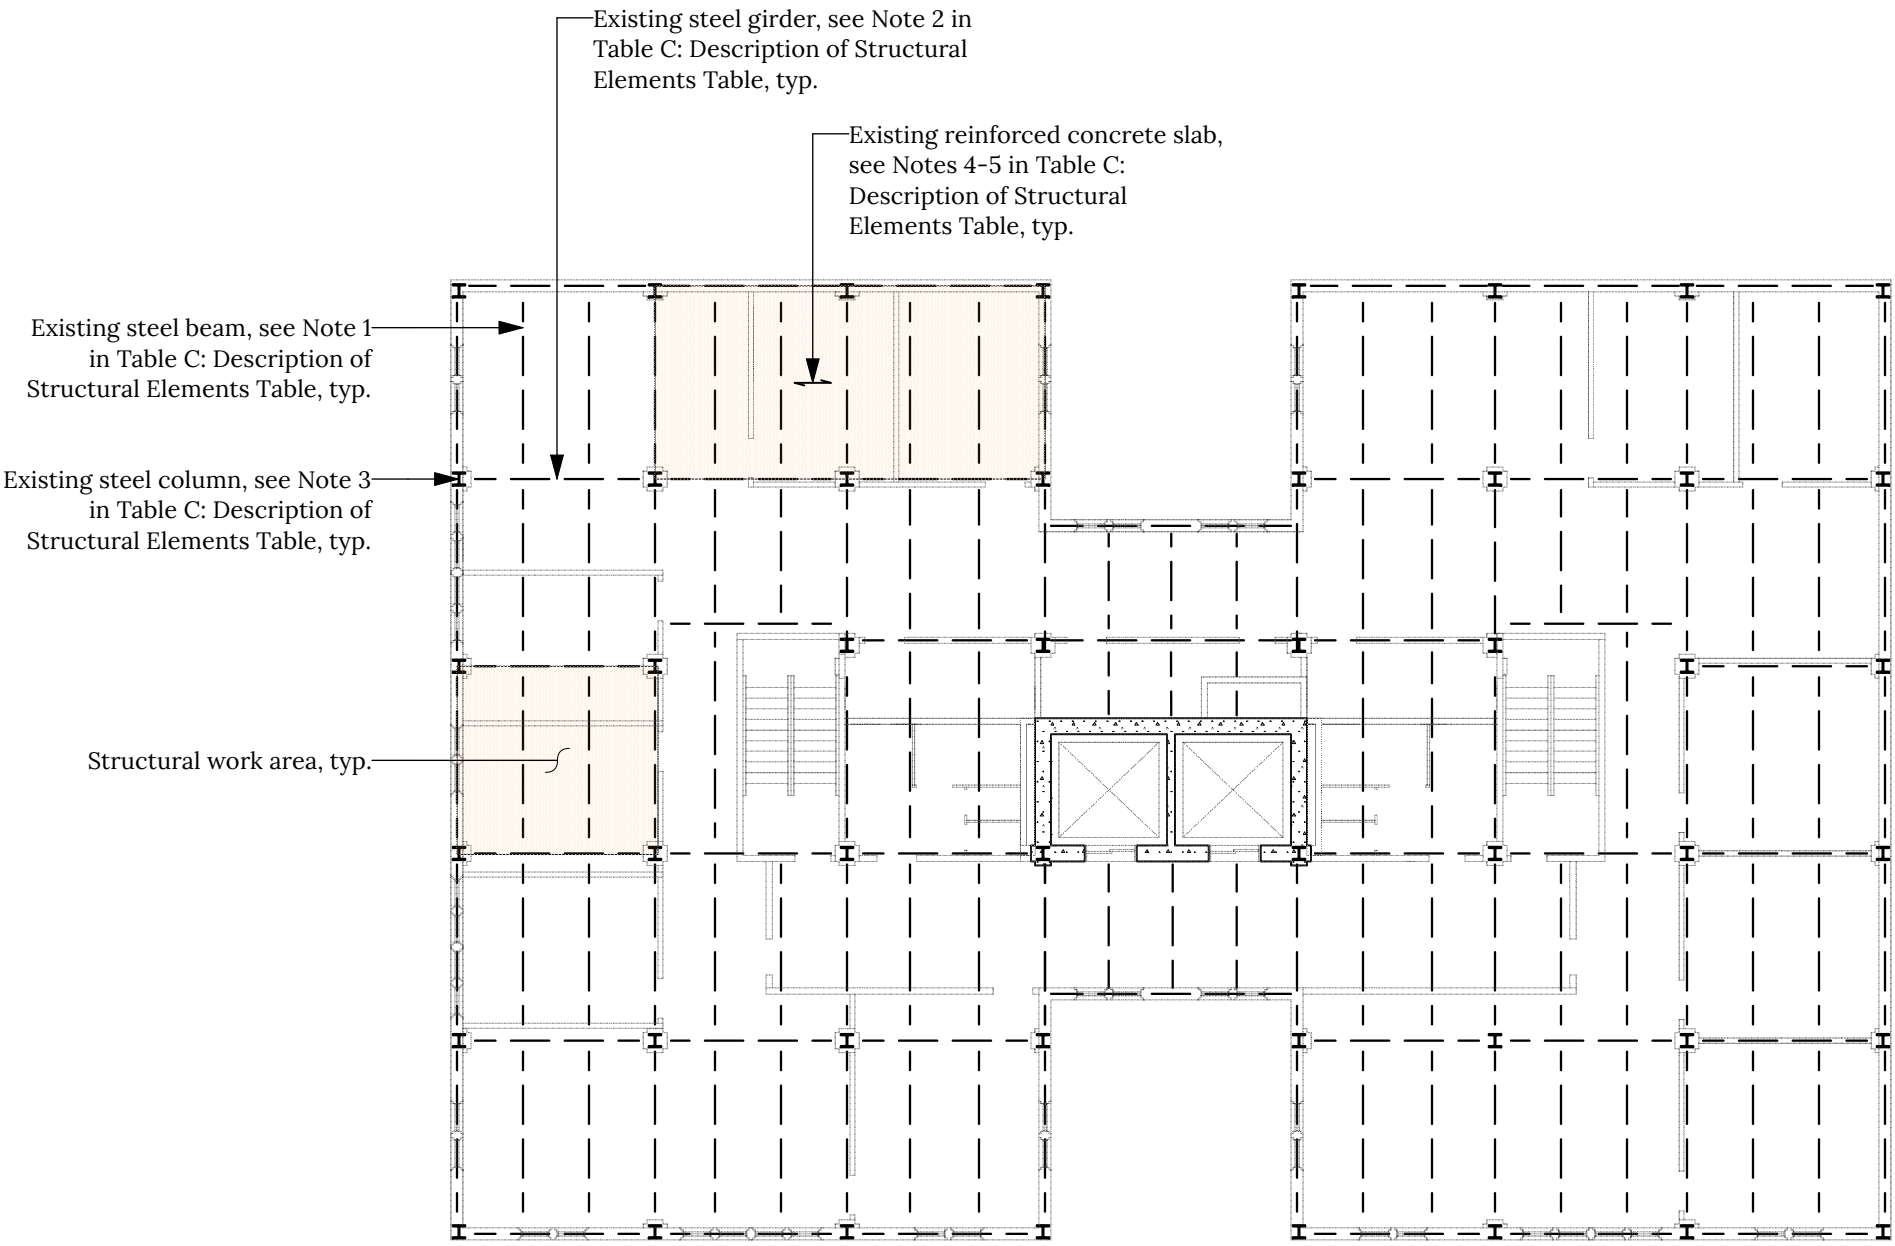
**S-010.00**

Note: Existing conditions assessment based on visual inspection of readily accessible and visible portions of area of structural assessment.

Analysis of load path:  
1. Existing reinforced concrete slab have sufficient capacity to support new live loads.  
2. Existing steel beams at areas of new, increased live loads are overstressed. Install new supplemental beams to reinforce floor at areas with new live loads.  
3. Existing steel girders have sufficient capacity to support new live loads.  
4. Existing steel columns have sufficient capacity to support new live loads.  
5. Existing foundations have sufficient capacity to support new live loads.

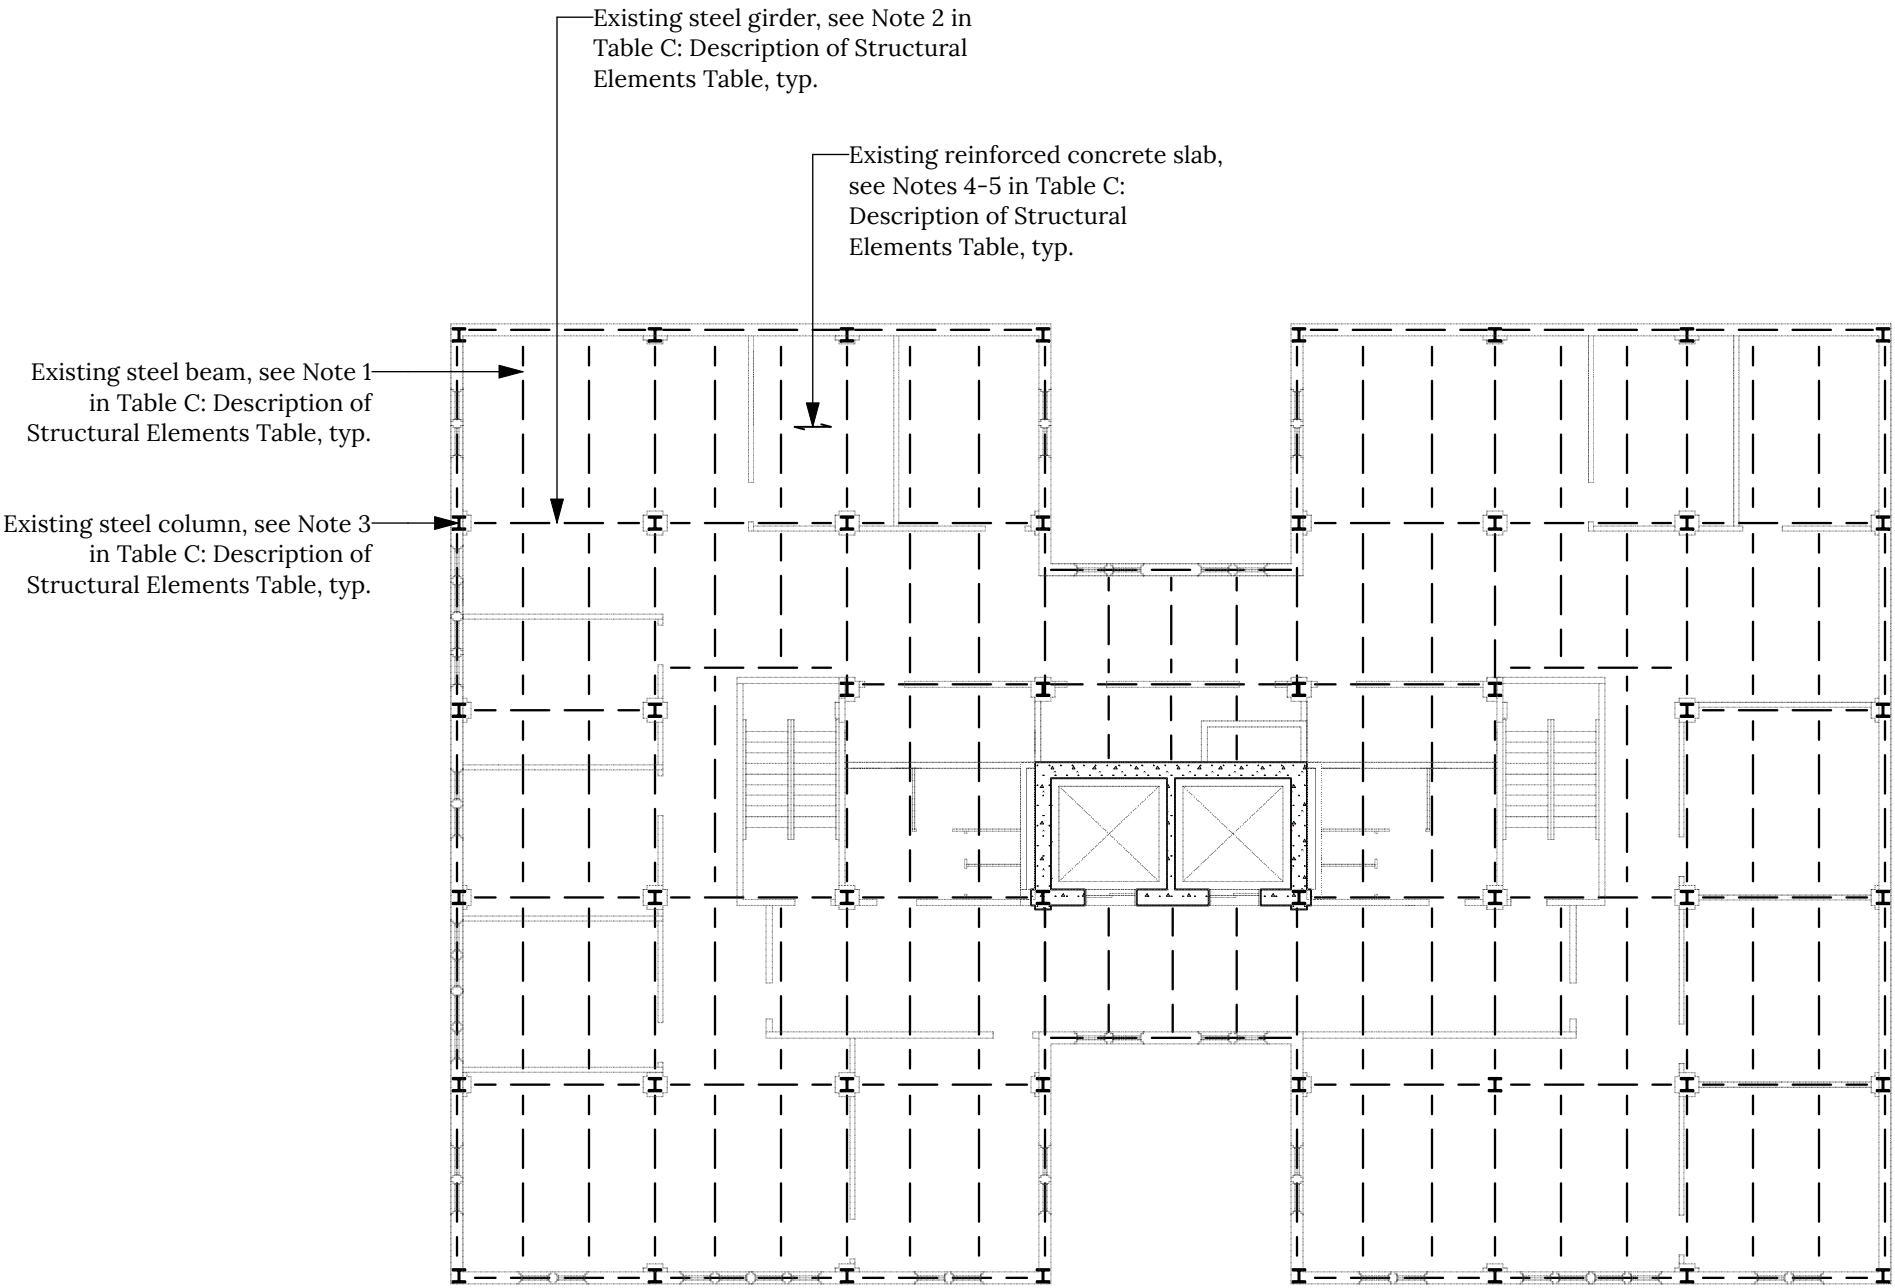
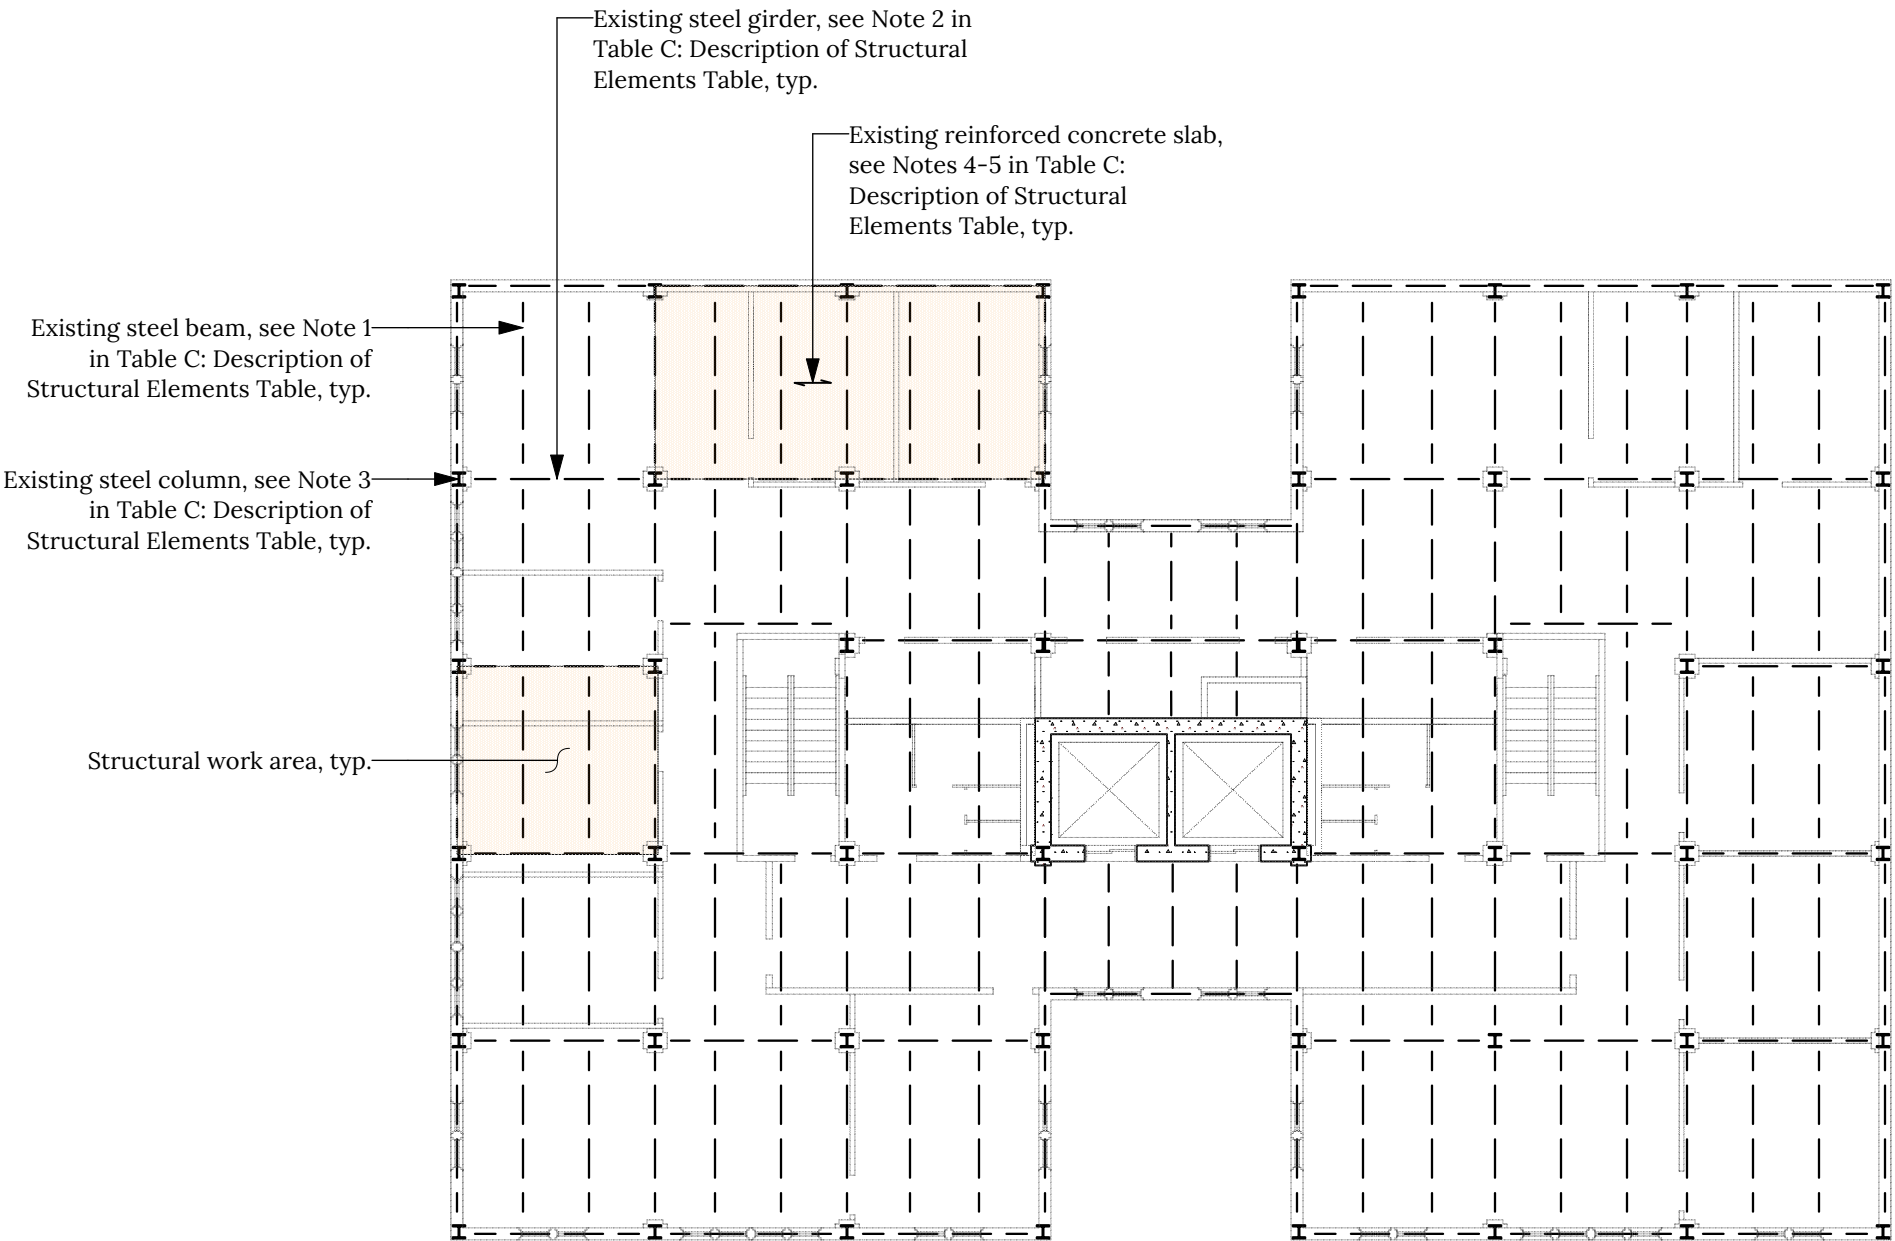
S-020.00

Note: Existing conditions assessment based on visual inspection of readily accessible and visible portions of area of structural assessment.

- Existing reinforced concrete slab have sufficient capacity to support new live loads.
- Existing steel beams at areas of new, increased live loads are overstressed. Install new supplemental beams to reinforce floor at areas with new live loads.
- Existing steel girders have sufficient capacity to support new live loads.
- Existing steel columns have sufficient capacity to support new live loads.
- Existing foundations have sufficient capacity to support new live loads.
