Phase II Work Plan

Fulton and Chelsea-Elliott

September 2023

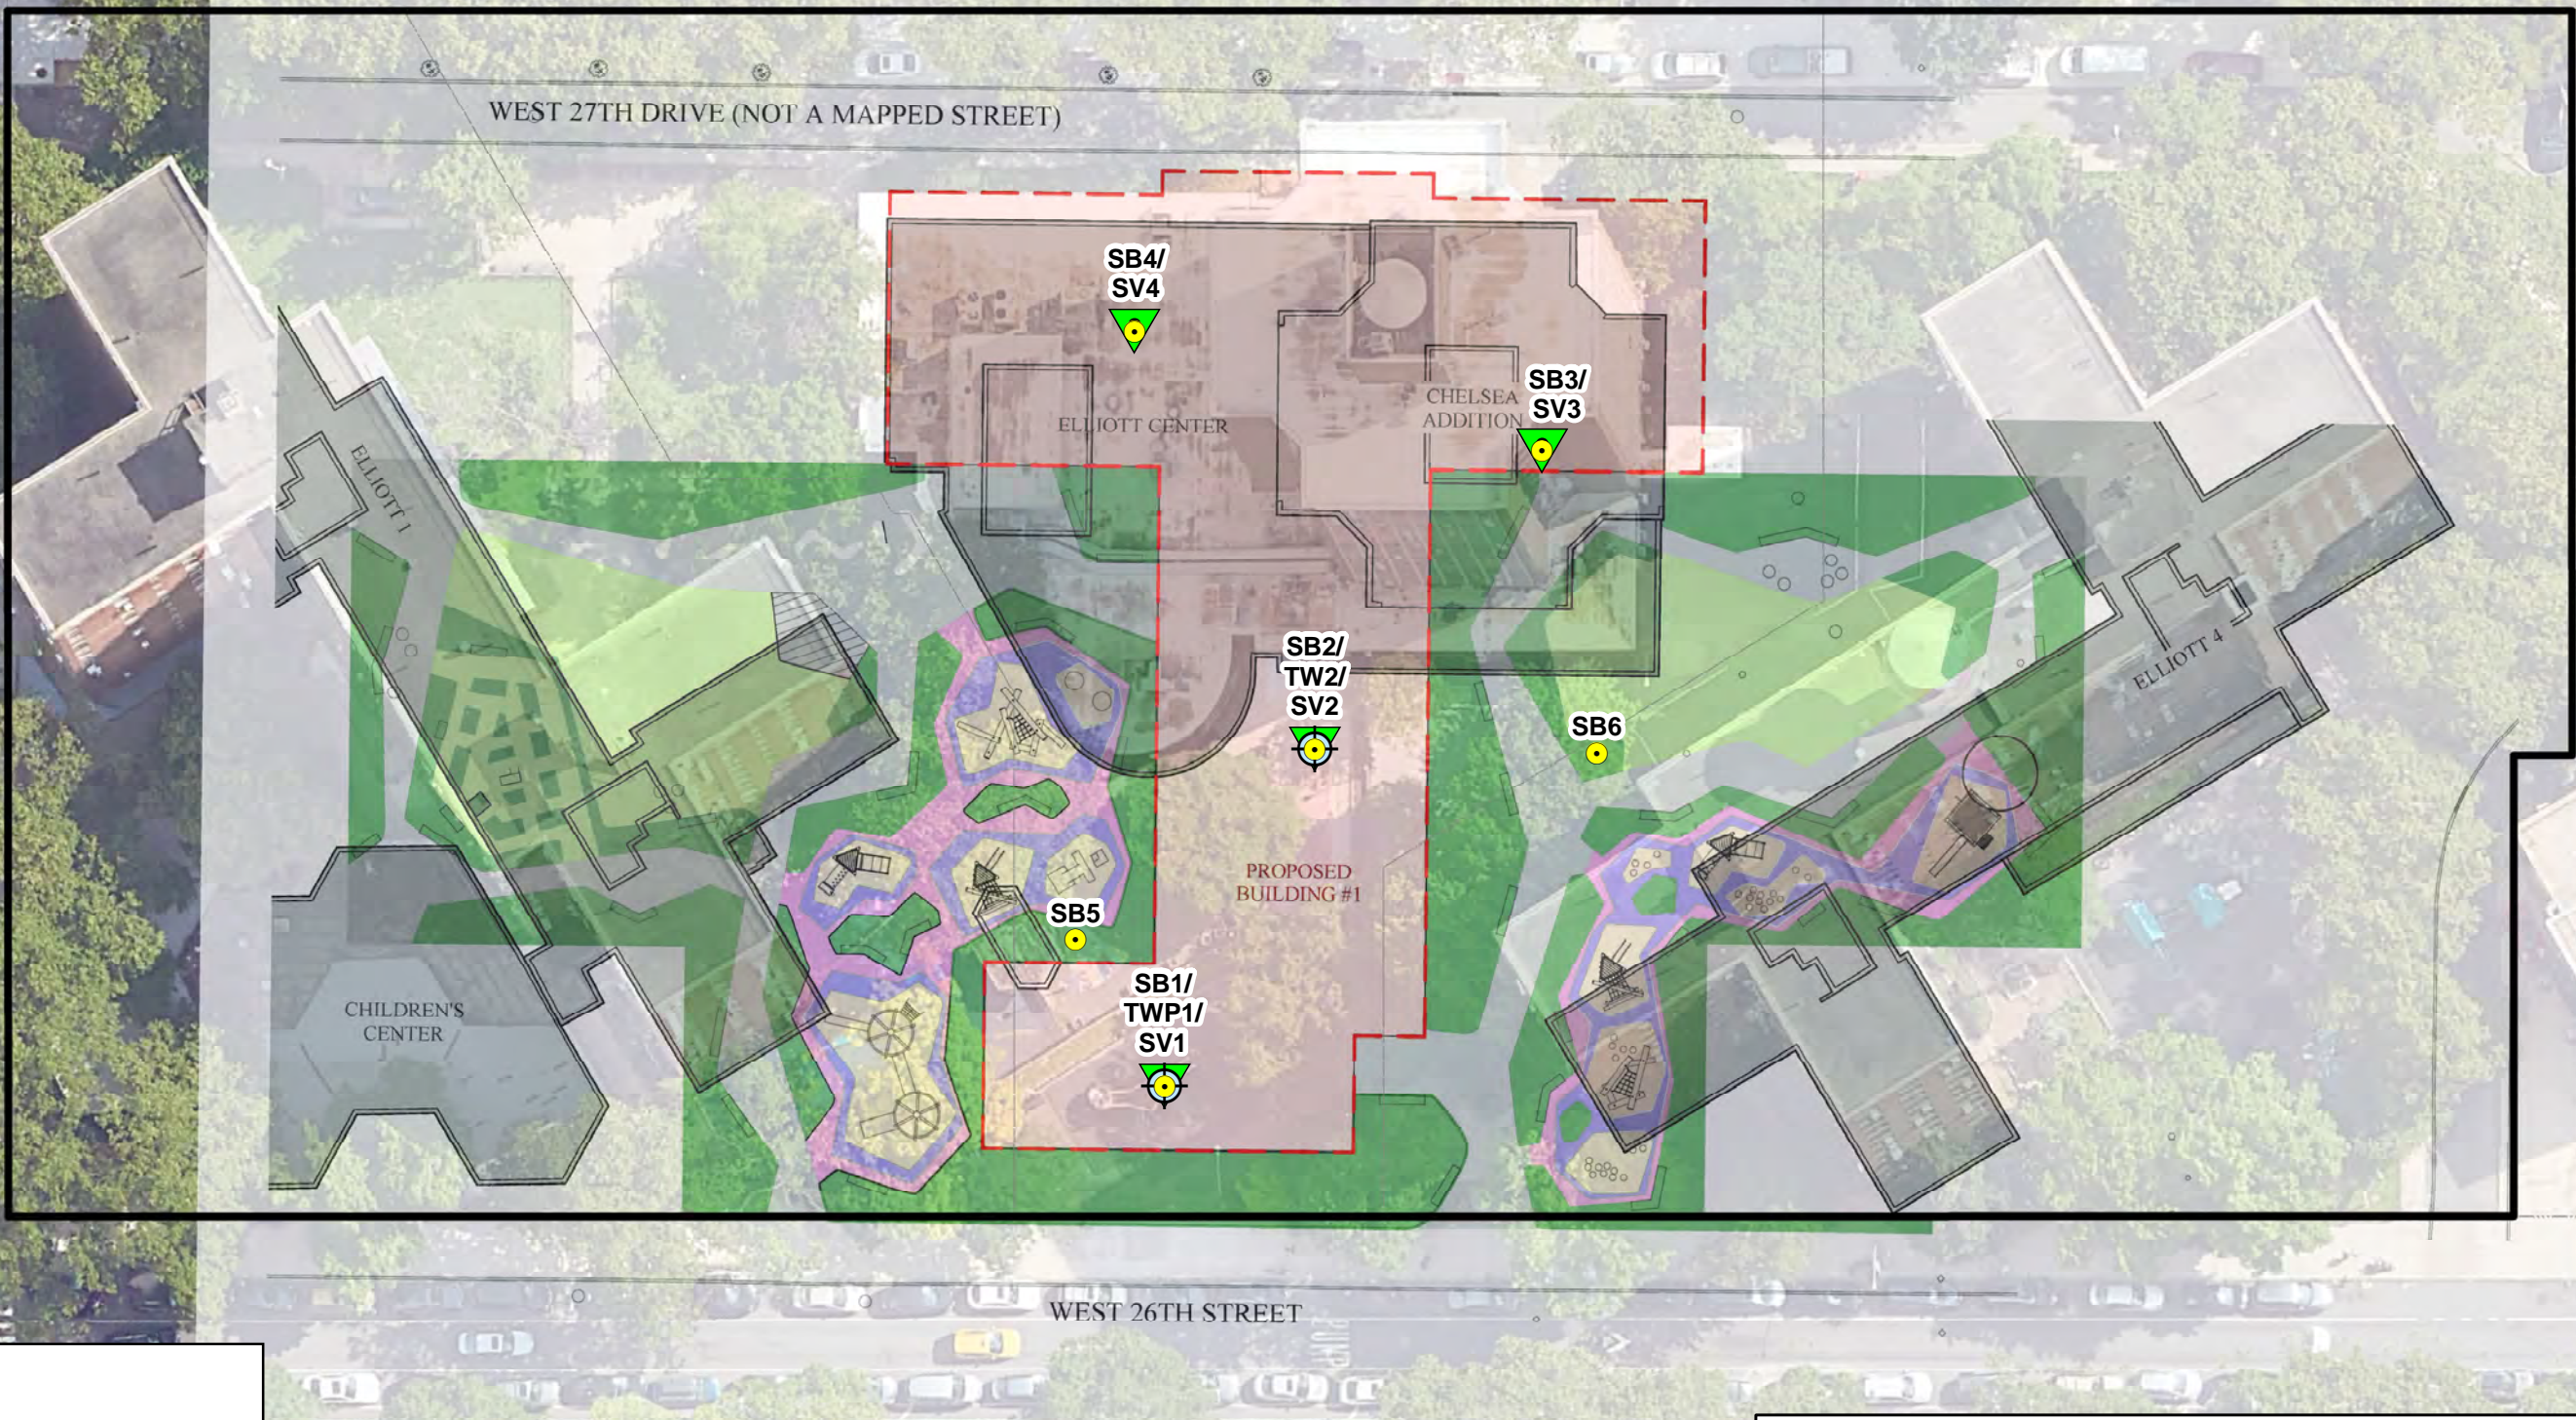
ADDITIONAL NOTES:
1. EXISTING BASEMENT IS 10 FEET BELOW GRADE.
2. PROPOSED BASEMENT WILL BE 10 FEET BELOW GRADE.

As part of the vapor intrusion evaluation, a tracer gas will be used in accordance with NYSDOH protocols to serve as a quality assurance/quality control (QA/QC) device to verify the integrity of the soil vapor probe seal. A container (box, plastic pail, etc.) will serve to keep the tracer gas in contact with the probe during testing. A portable monitoring device will be used to analyze a sample of soil vapor for the tracer gas prior to sampling. If the tracer sample results show a significant presence of the tracer, the probe seals will be adjusted to prevent infiltration. At the conclusion of the sampling round, tracer monitoring will be performed a second time to confirm the integrity of the probe seals. The locations of the proposed soil vapor, indoor air and ambient air samples are shown on Figures 2A and 2B.
