**Preservation Department – Item 3, LPC-26-06012**

**70 Fifth Avenue (aka 2-6 West 13th Street) –  
Educational Building – Individual Landmark**

Landmarks Preservation Commission  
Public Hearing

Bacon Lane Architects - Architect of Record

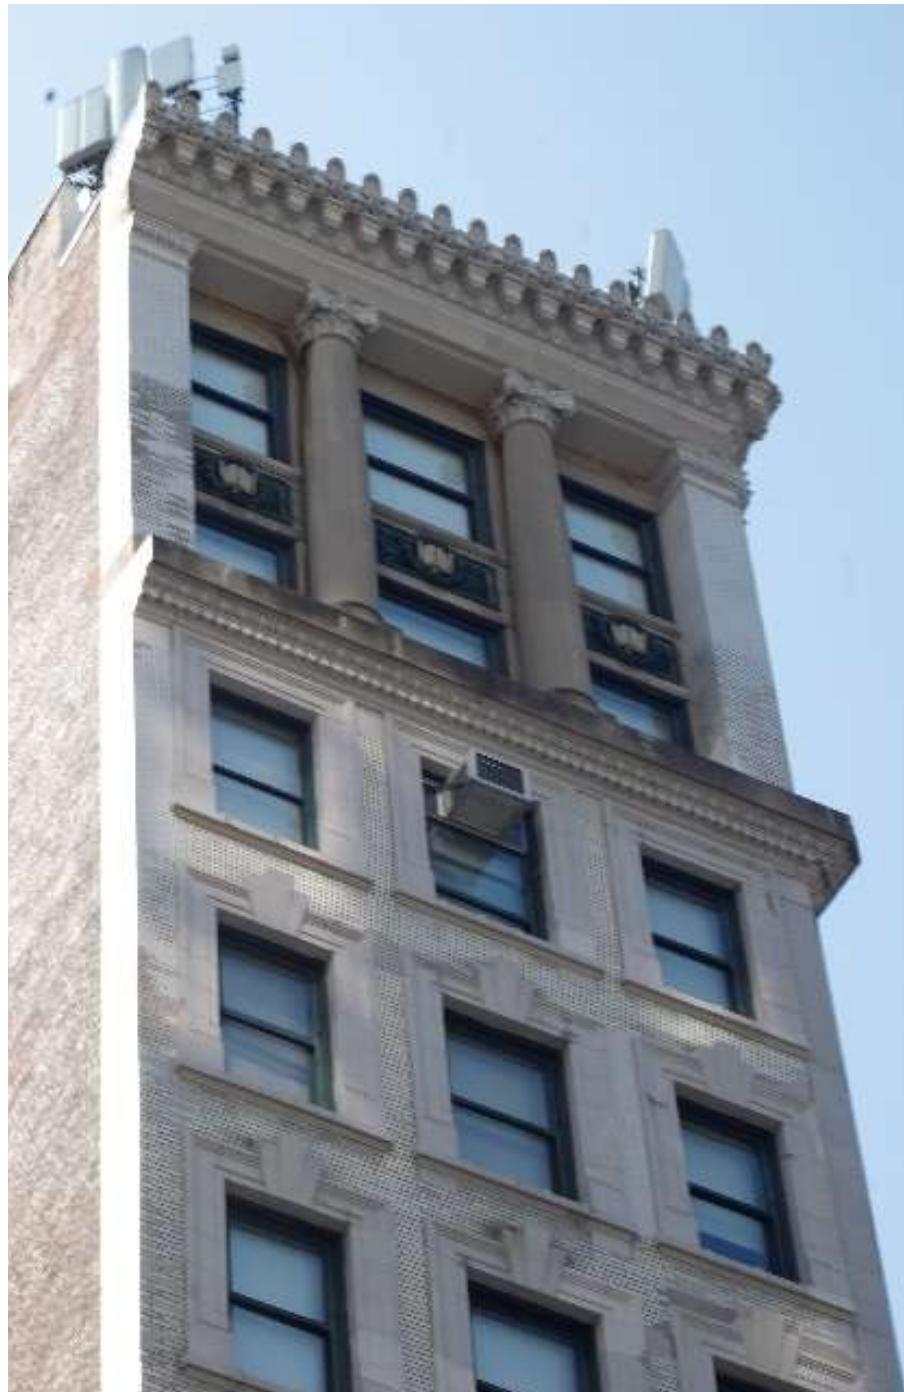
View of parapet cornice  
(Image from NYC LPC Designation Report)

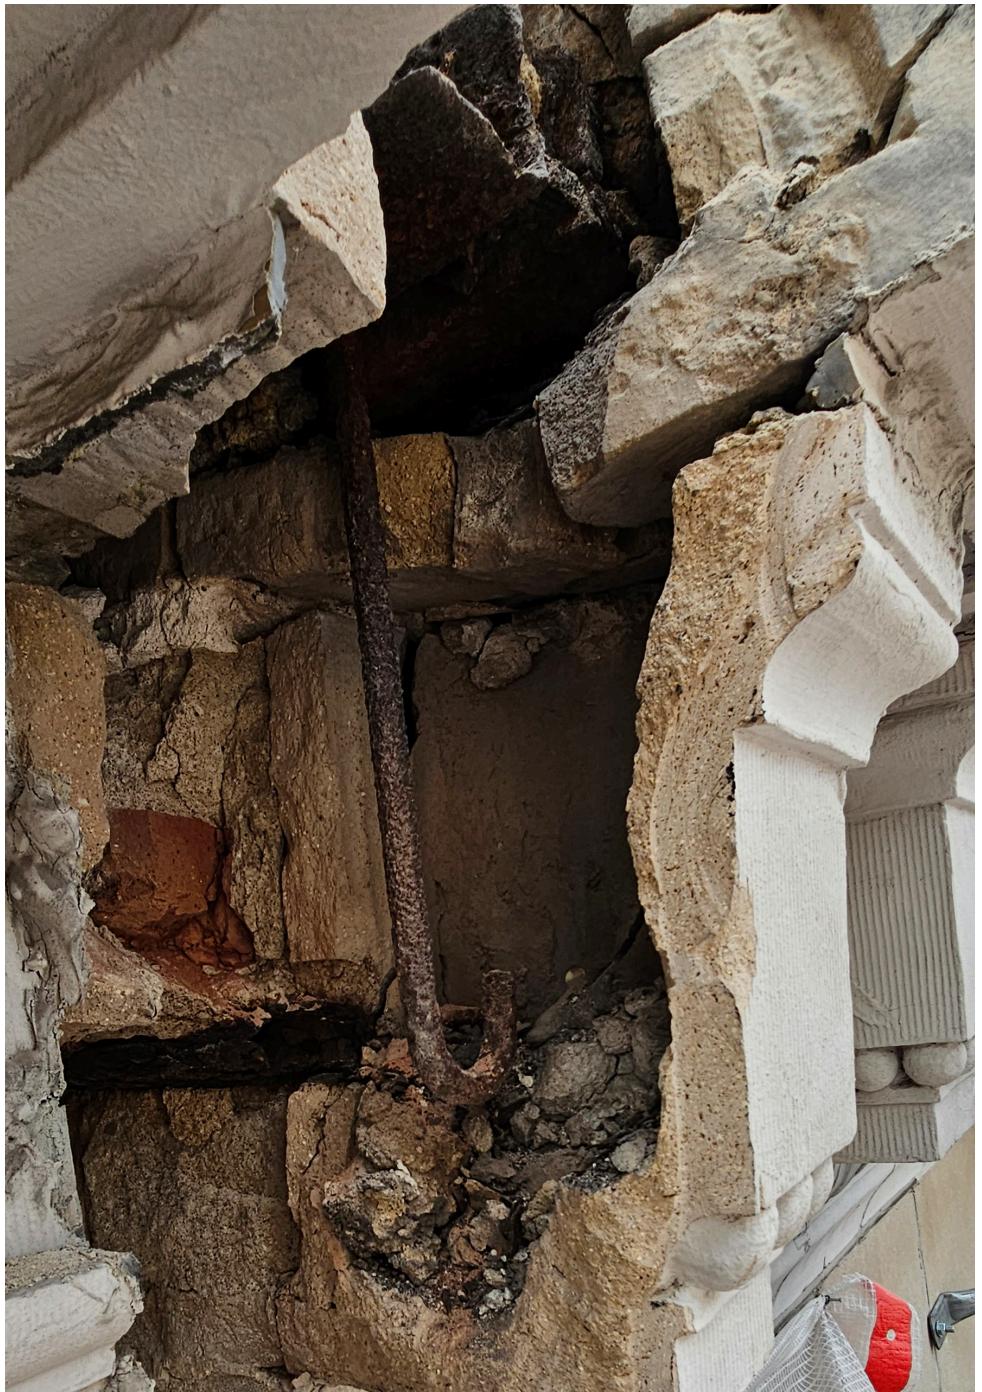
Deterioration of steel anchor embedments

1. Existing parapet does not have sufficient capacity to support the terracotta cornice, causing the load to be transferred to the building facade.
2. Reducing the cornice load allows the parapet to adequately support the remaining loads.
3. Removing compressive forces from the facade reduces stress, assisting in preventing future cracking to preserve the building.

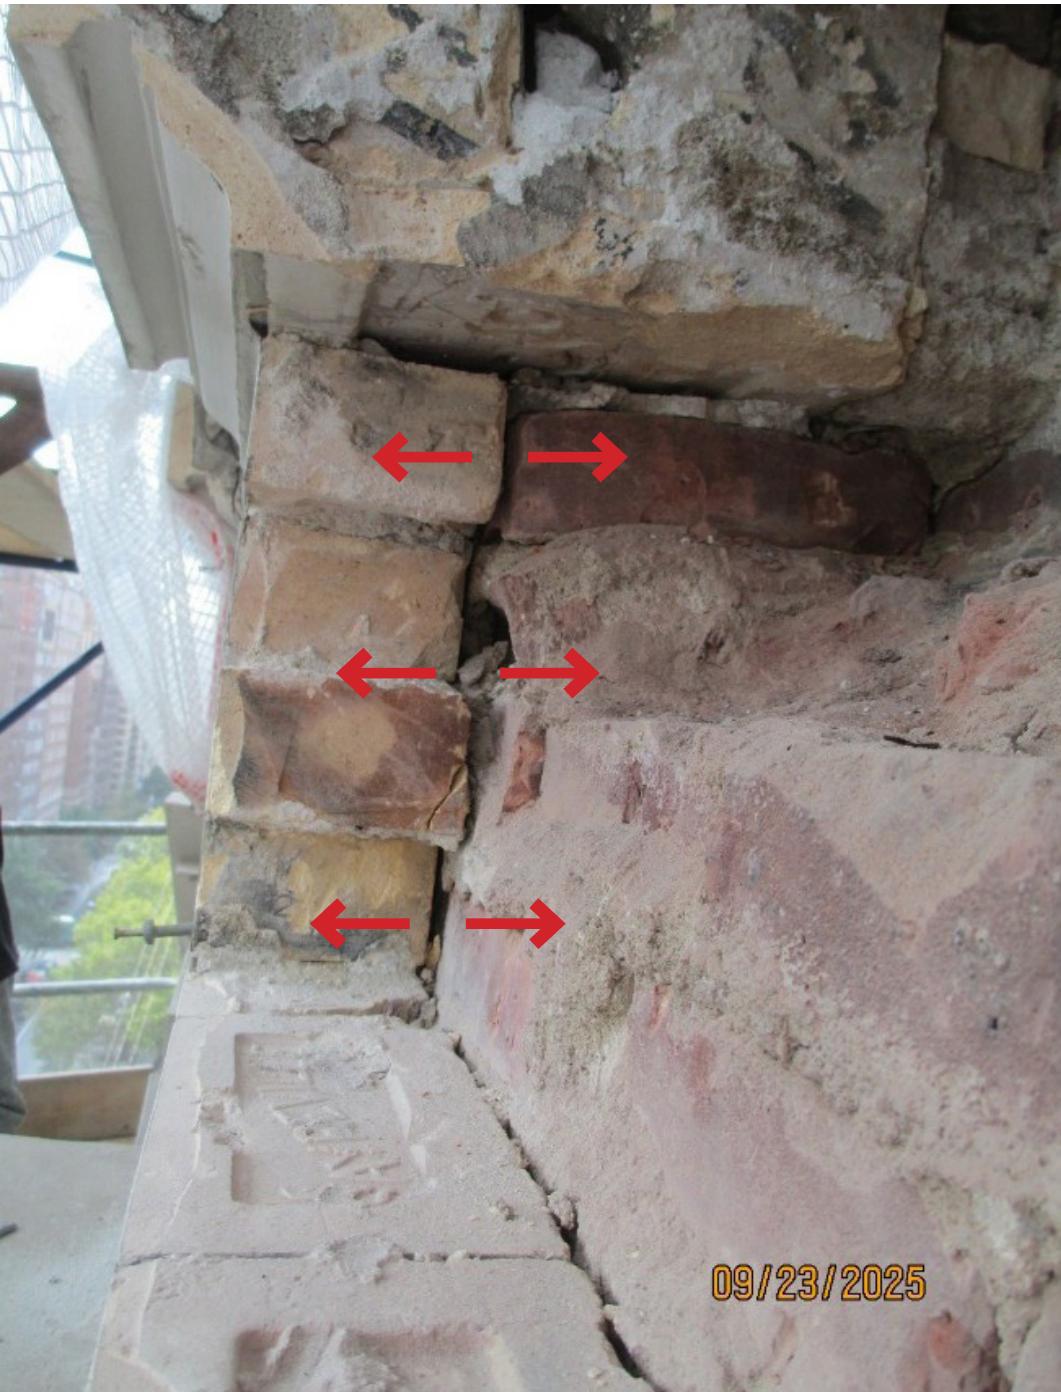
Separation between face brick and back-up brick masonry  
back up wall due to lack of header course

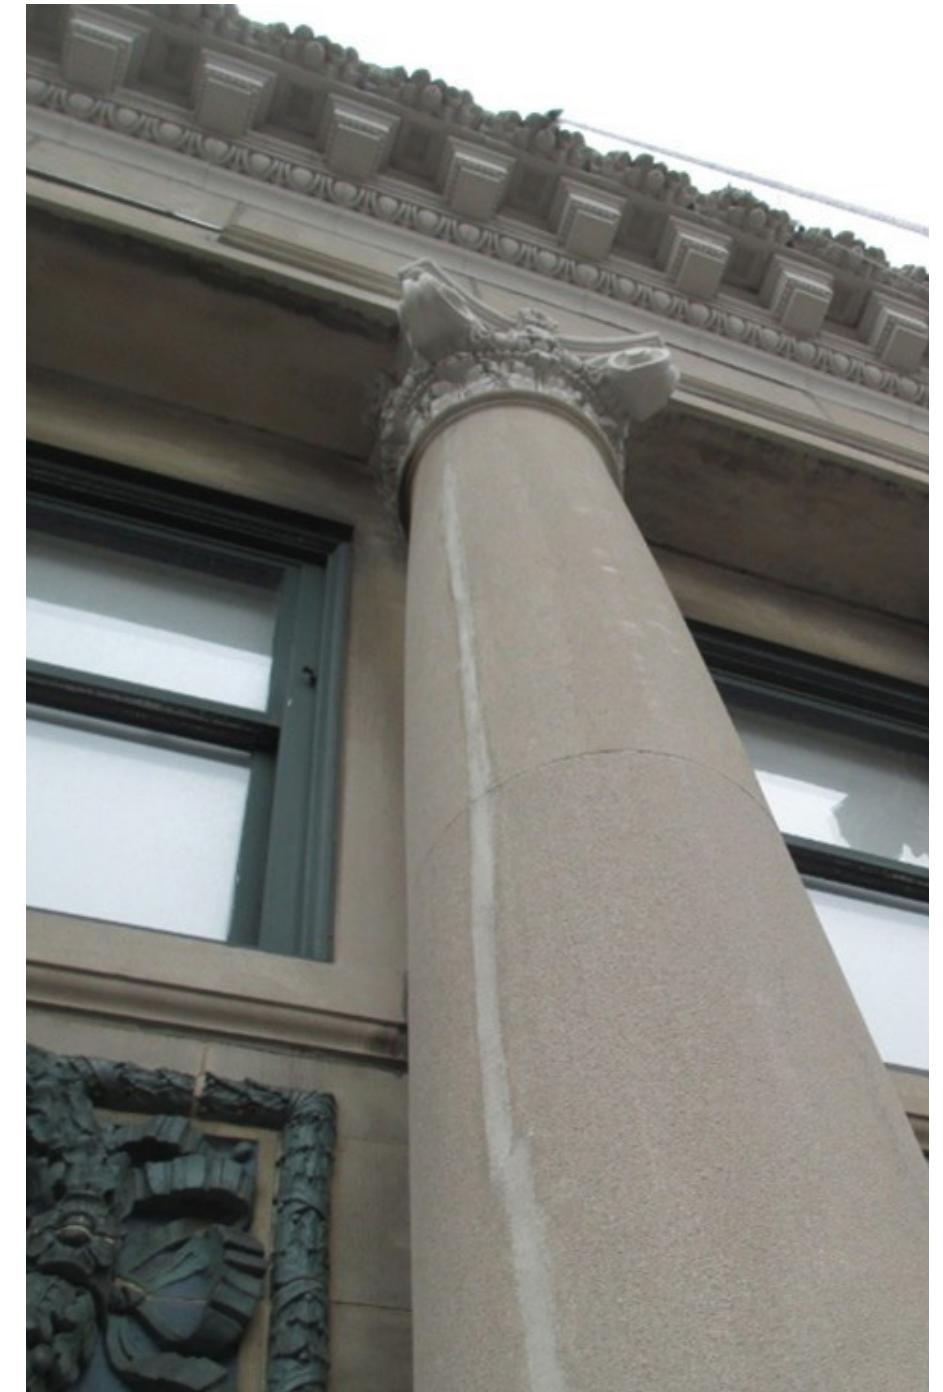
Continuous vertical cracking at limestone  
due to compression forces

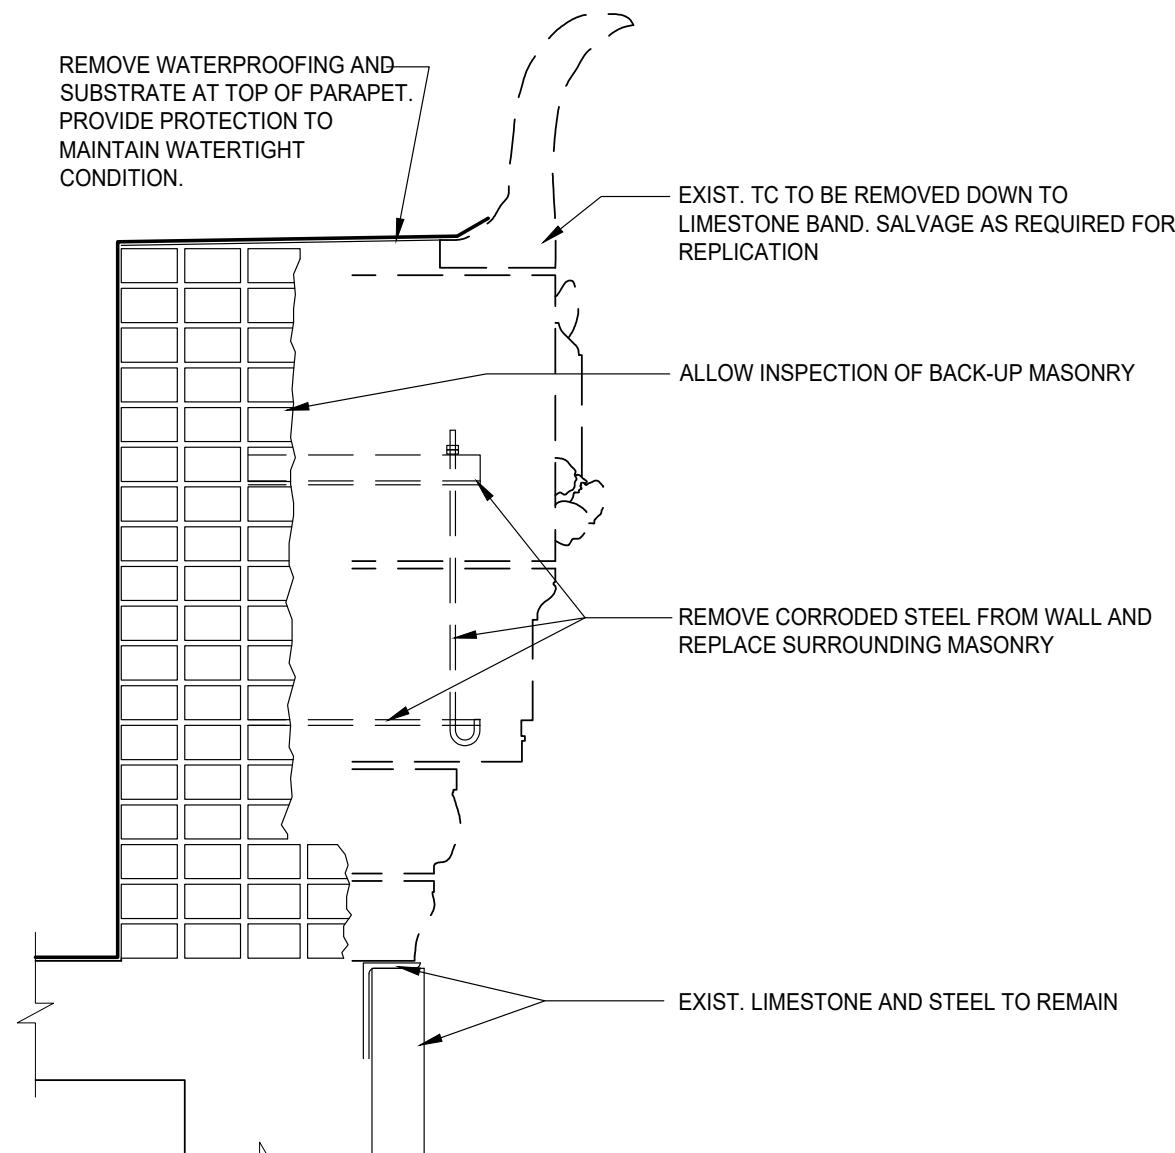
Cornice demolition

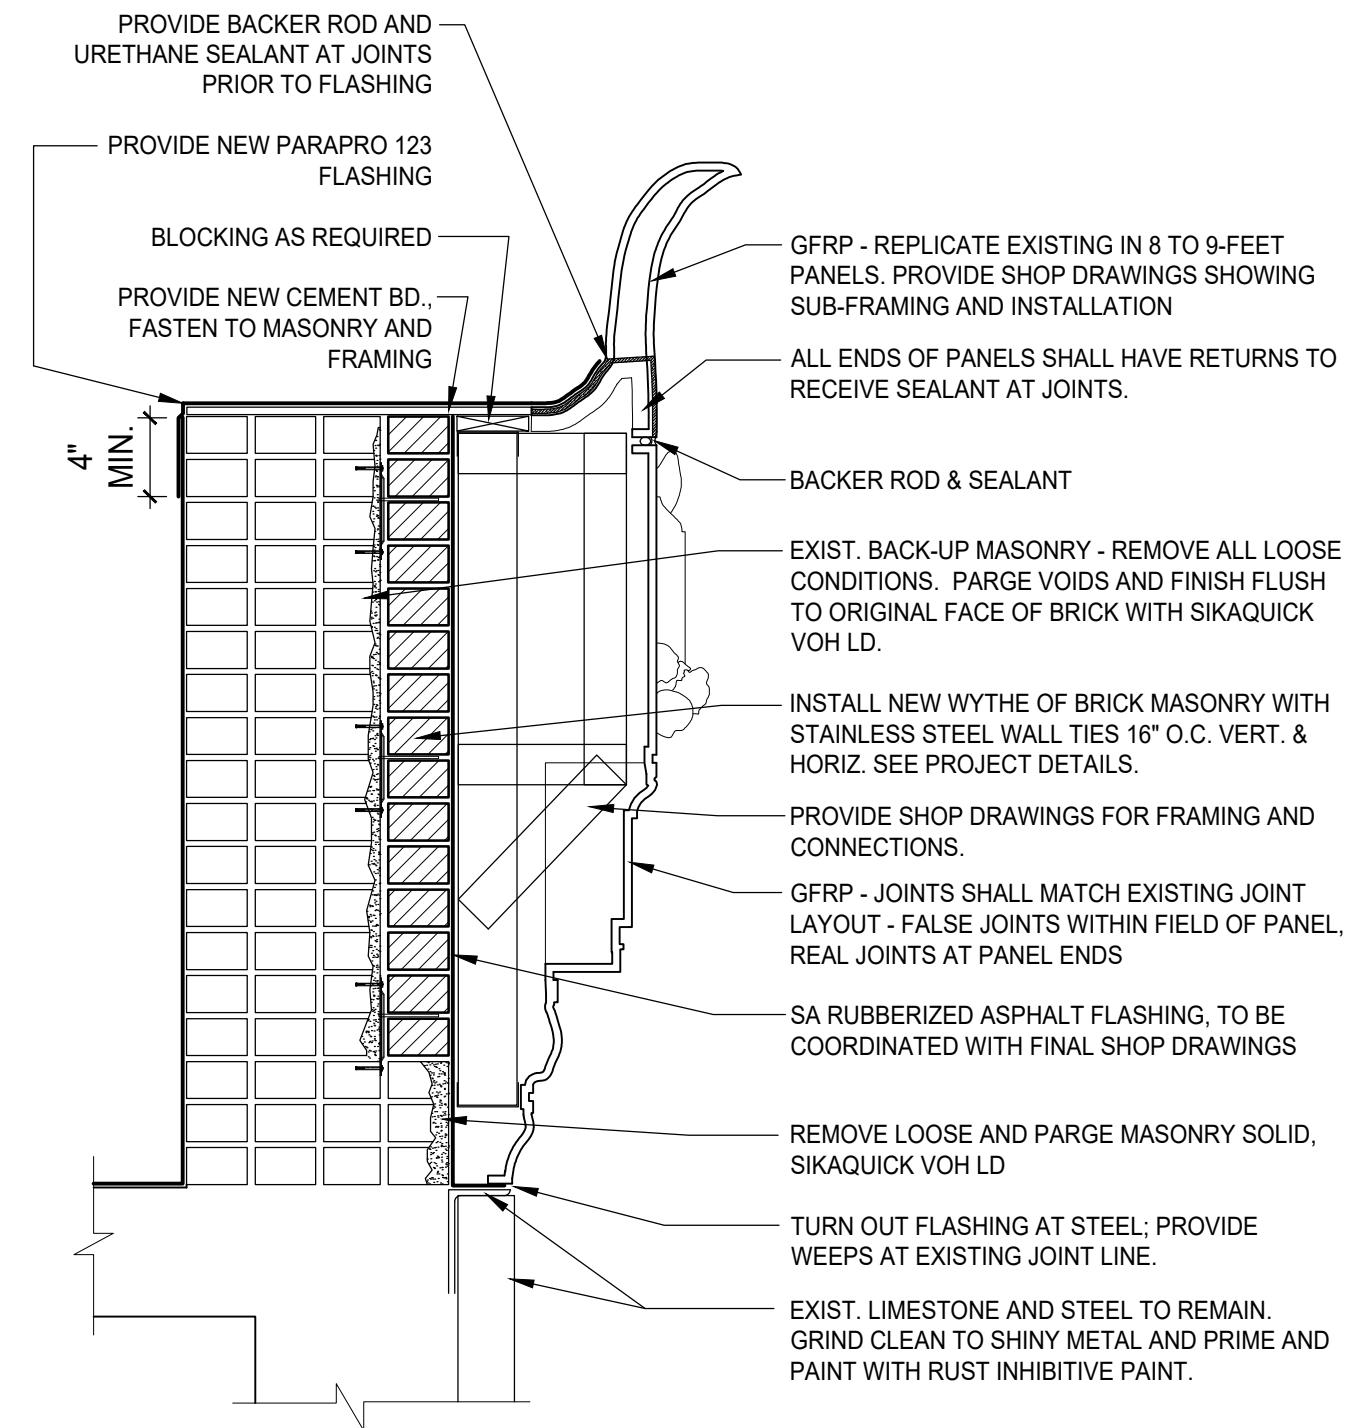
New cornice

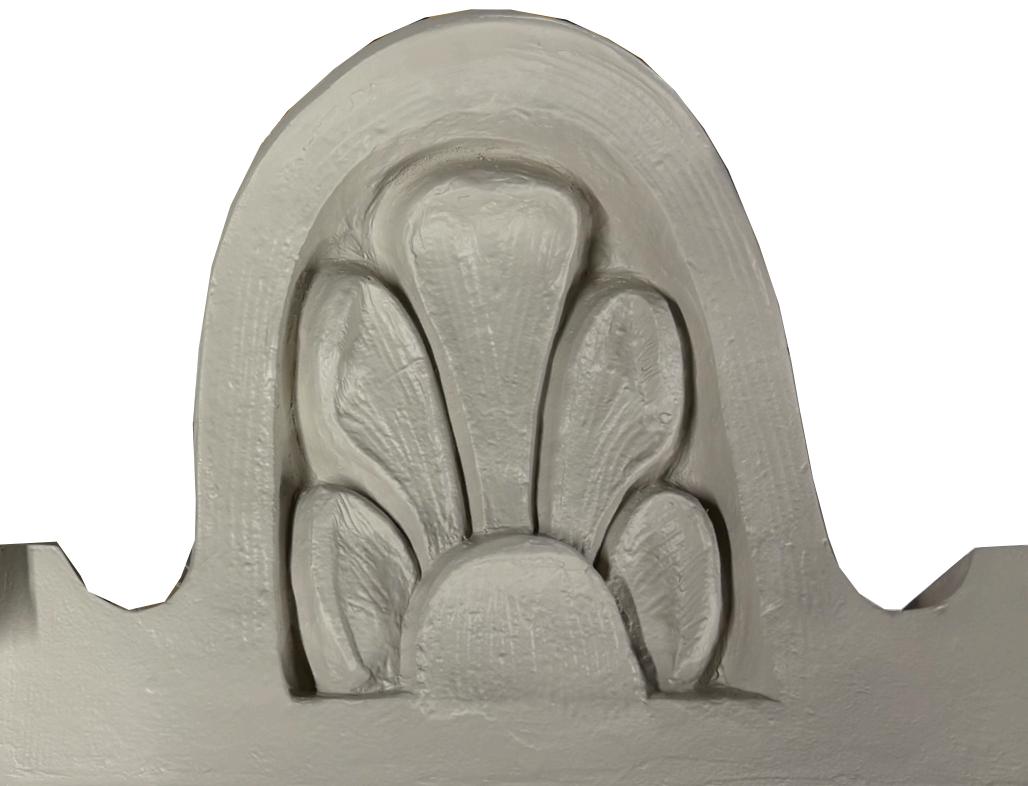
**Uncoated** GFRP sample  
Coating color & sheen to be colormatched

— New joint locations to align with existing seams

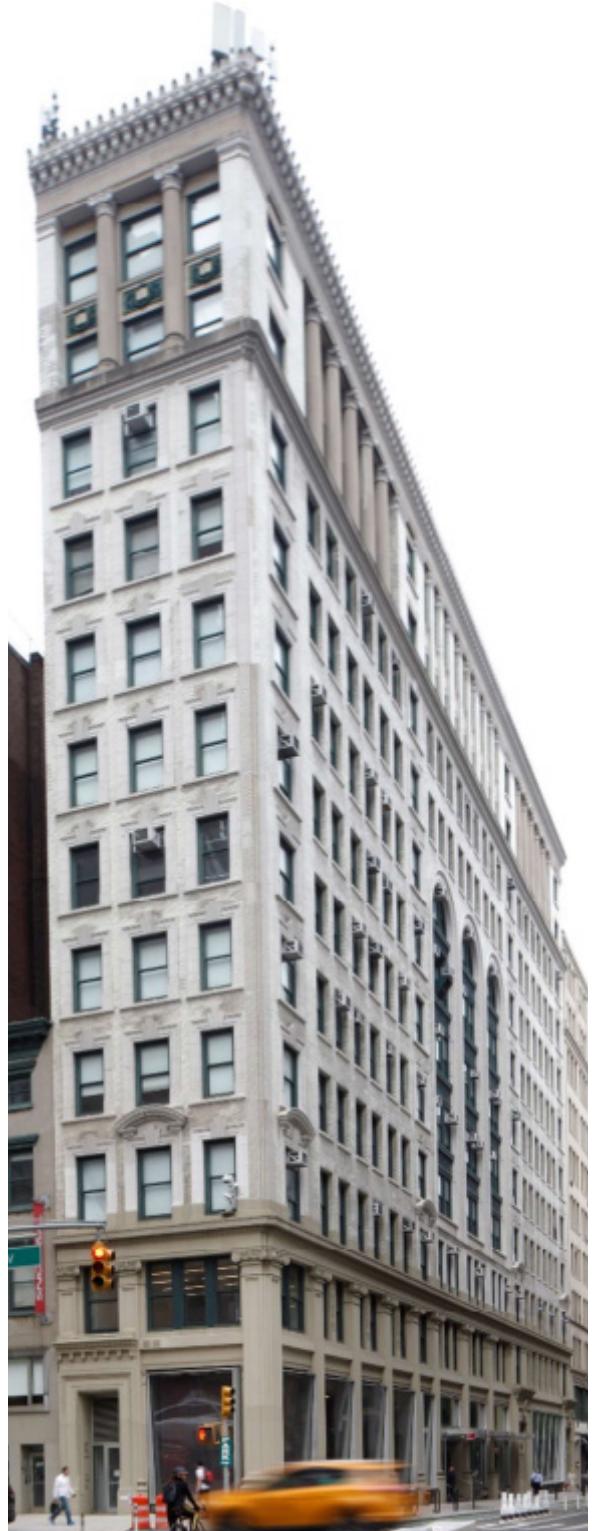
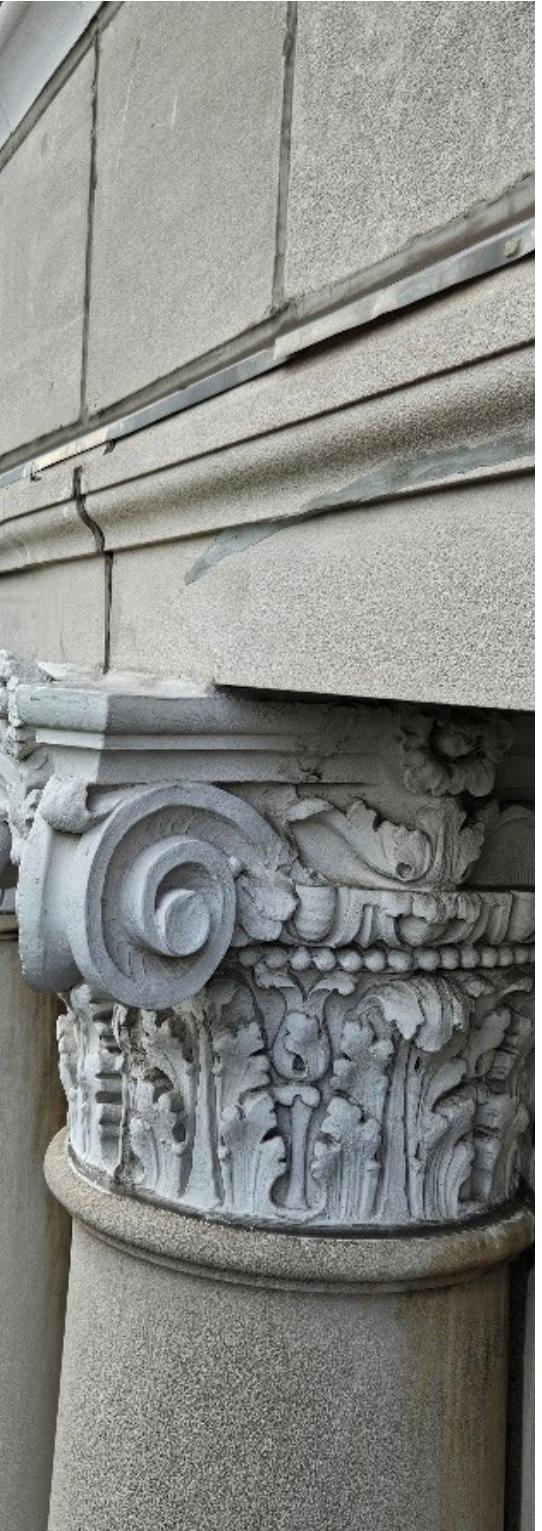
Existing painted column capital

**Staff Level Restoration**  
Custom coating to match existing  
Edison Coatings Inc.  
Aquathan breathable coating

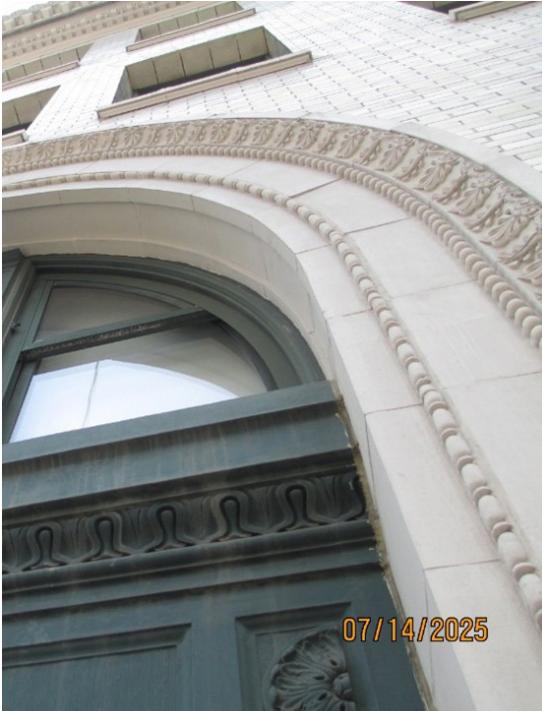
Existing painted window surrounds

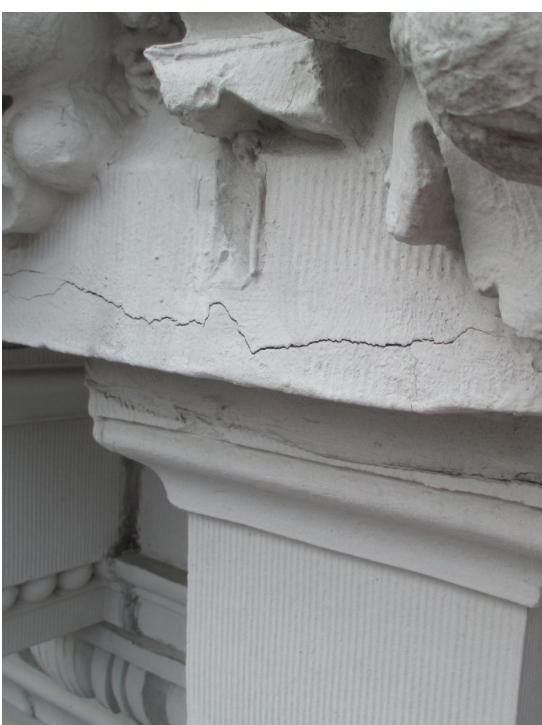
Existing painted cornice

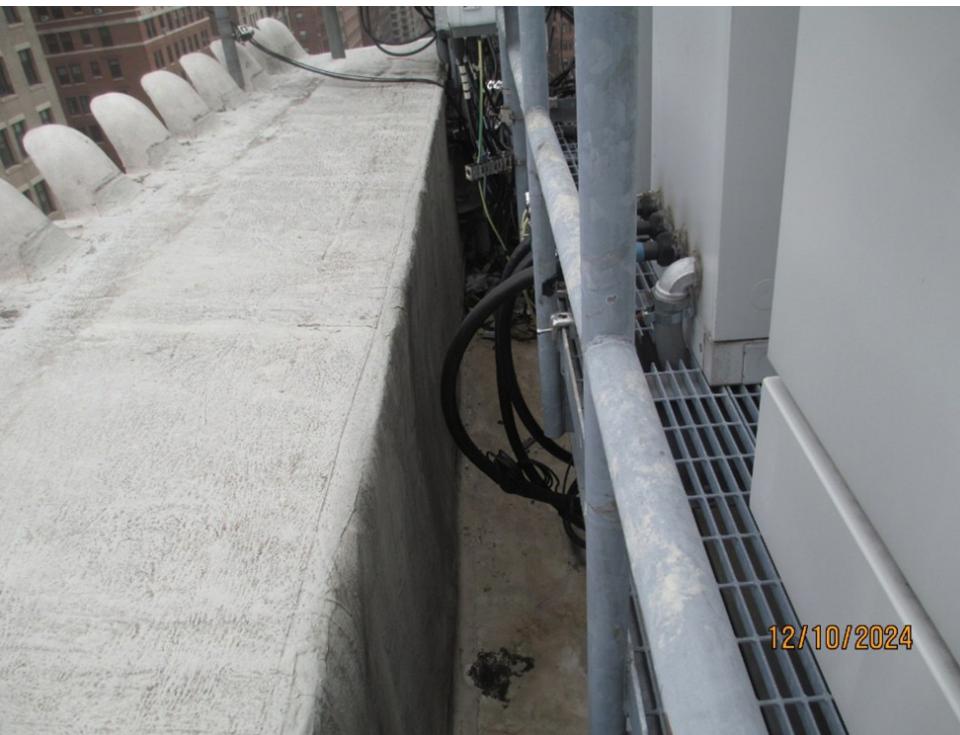
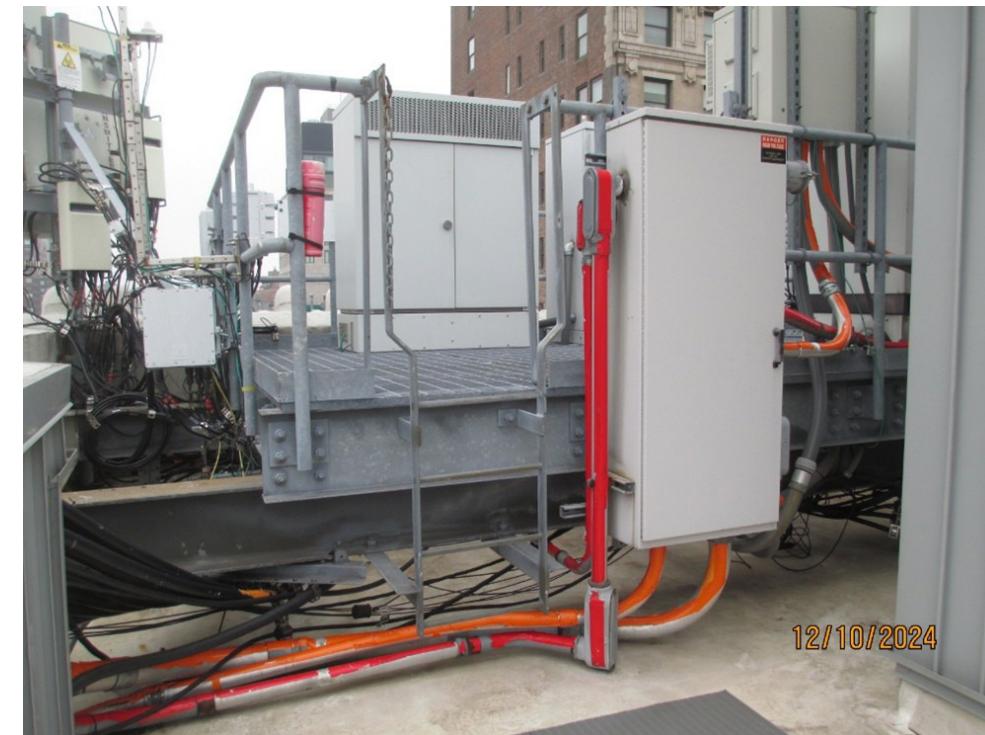
East parapet roof dunnage

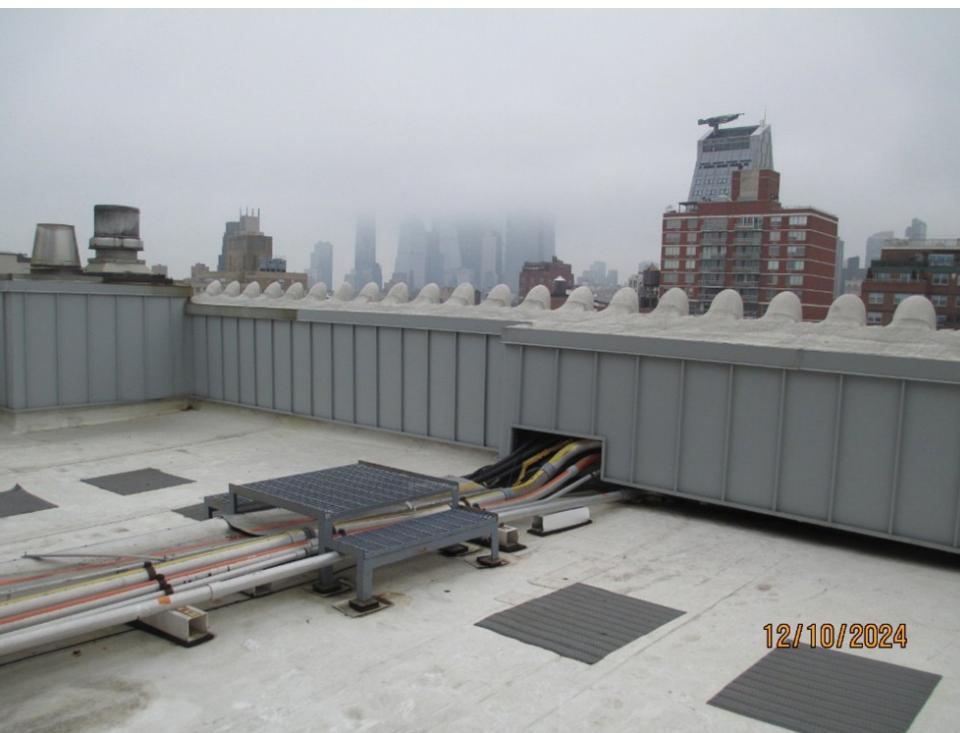
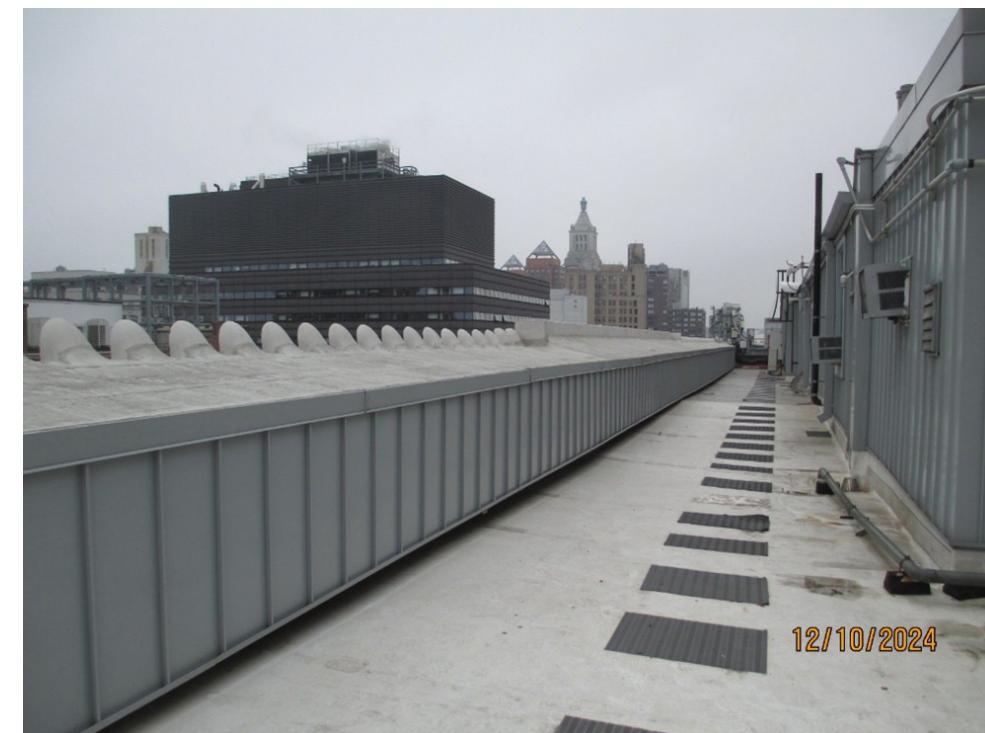
North parapet conduit chase
