Preservation Department – Item 3, LPC-26-03584

**83-85 Sullivan Street – Sullivan-Thompson Historic District
Borough of Manhattan**

PRESENTATION TO:
LANDMARKS PRESERVATION COMMISSION

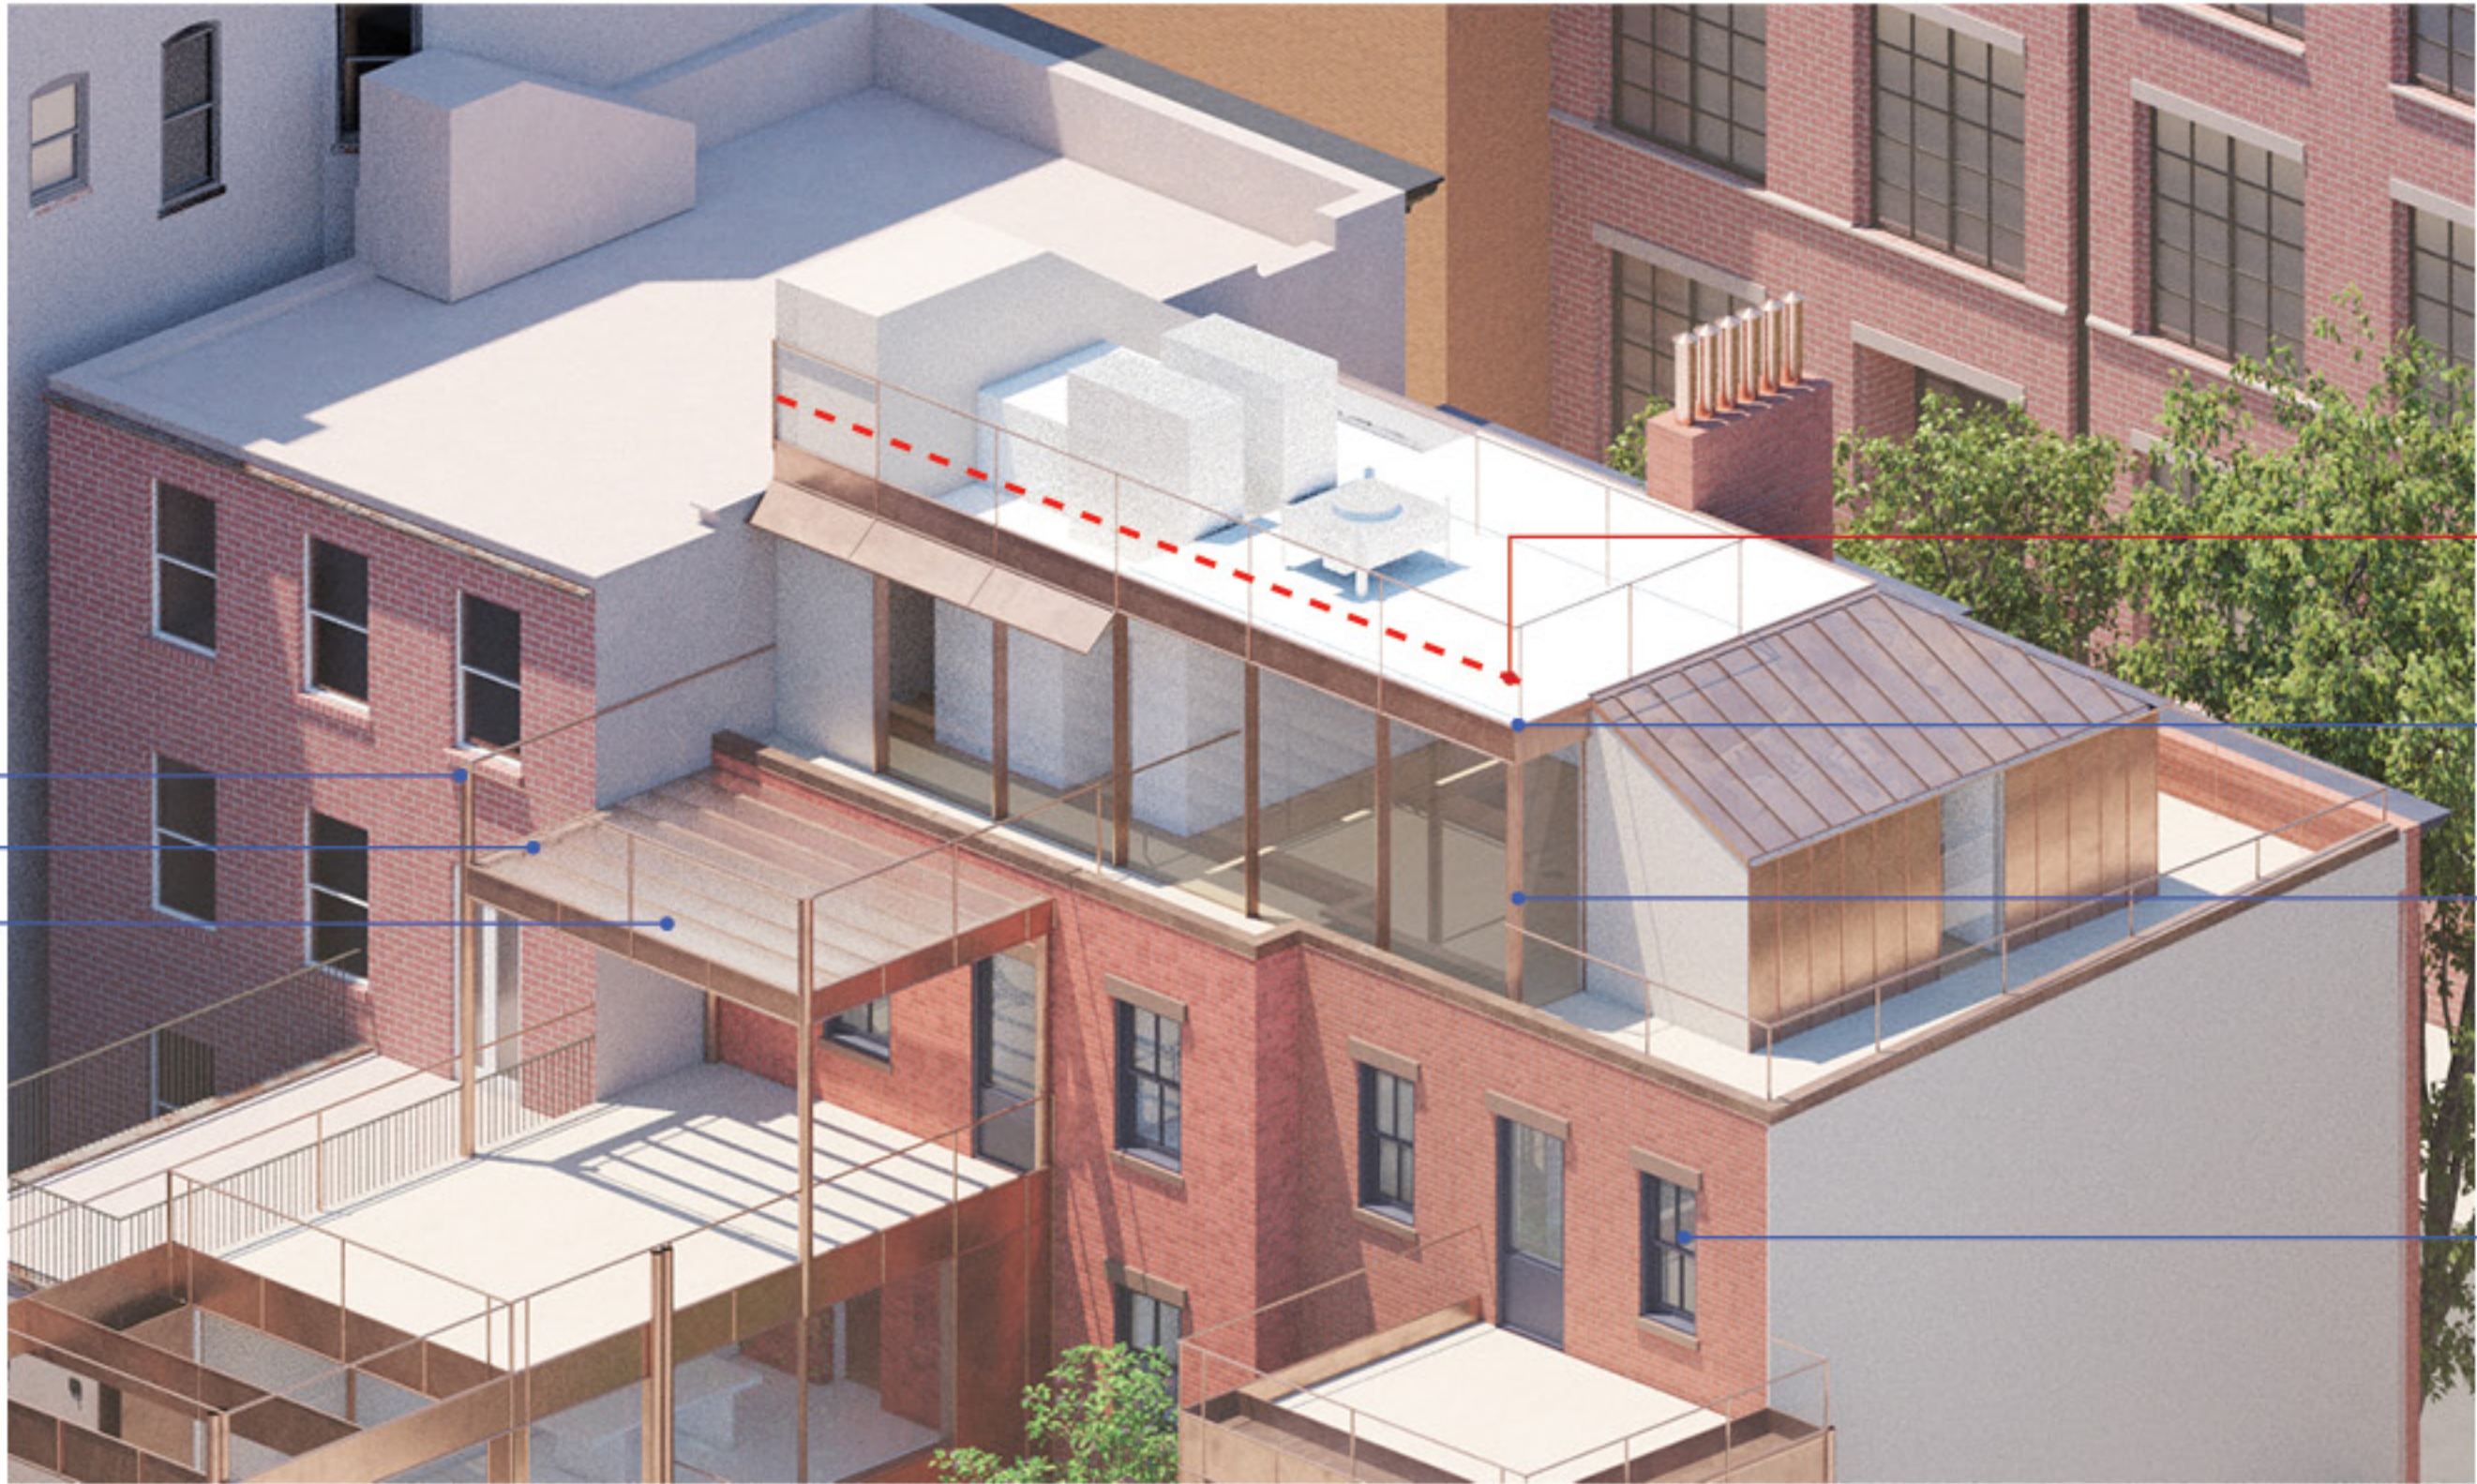
Currently Proposed Addition
Responses to Commissioners' Comments from 11/25/25 Public Hearing

Third floor addition at 83 Sullivan replaced with open porch with reduced footprint.

Reduced depth of fascia to increase visibility of continuous roof line at rear of historic mass.

Roof of open porch detailed with walkable glass surface for increased light at restored rear facade.

Roof addition ceiling height reduced by 1'-0". Depth of fascia further reduced to decrease overall appearance.

Vertical fins reduced to emphasize continuous historic roof line.

Windows at restored rear facade detailed to match the historic 2-over-2 windows at the front facade. Doors detailed to match window proportions.

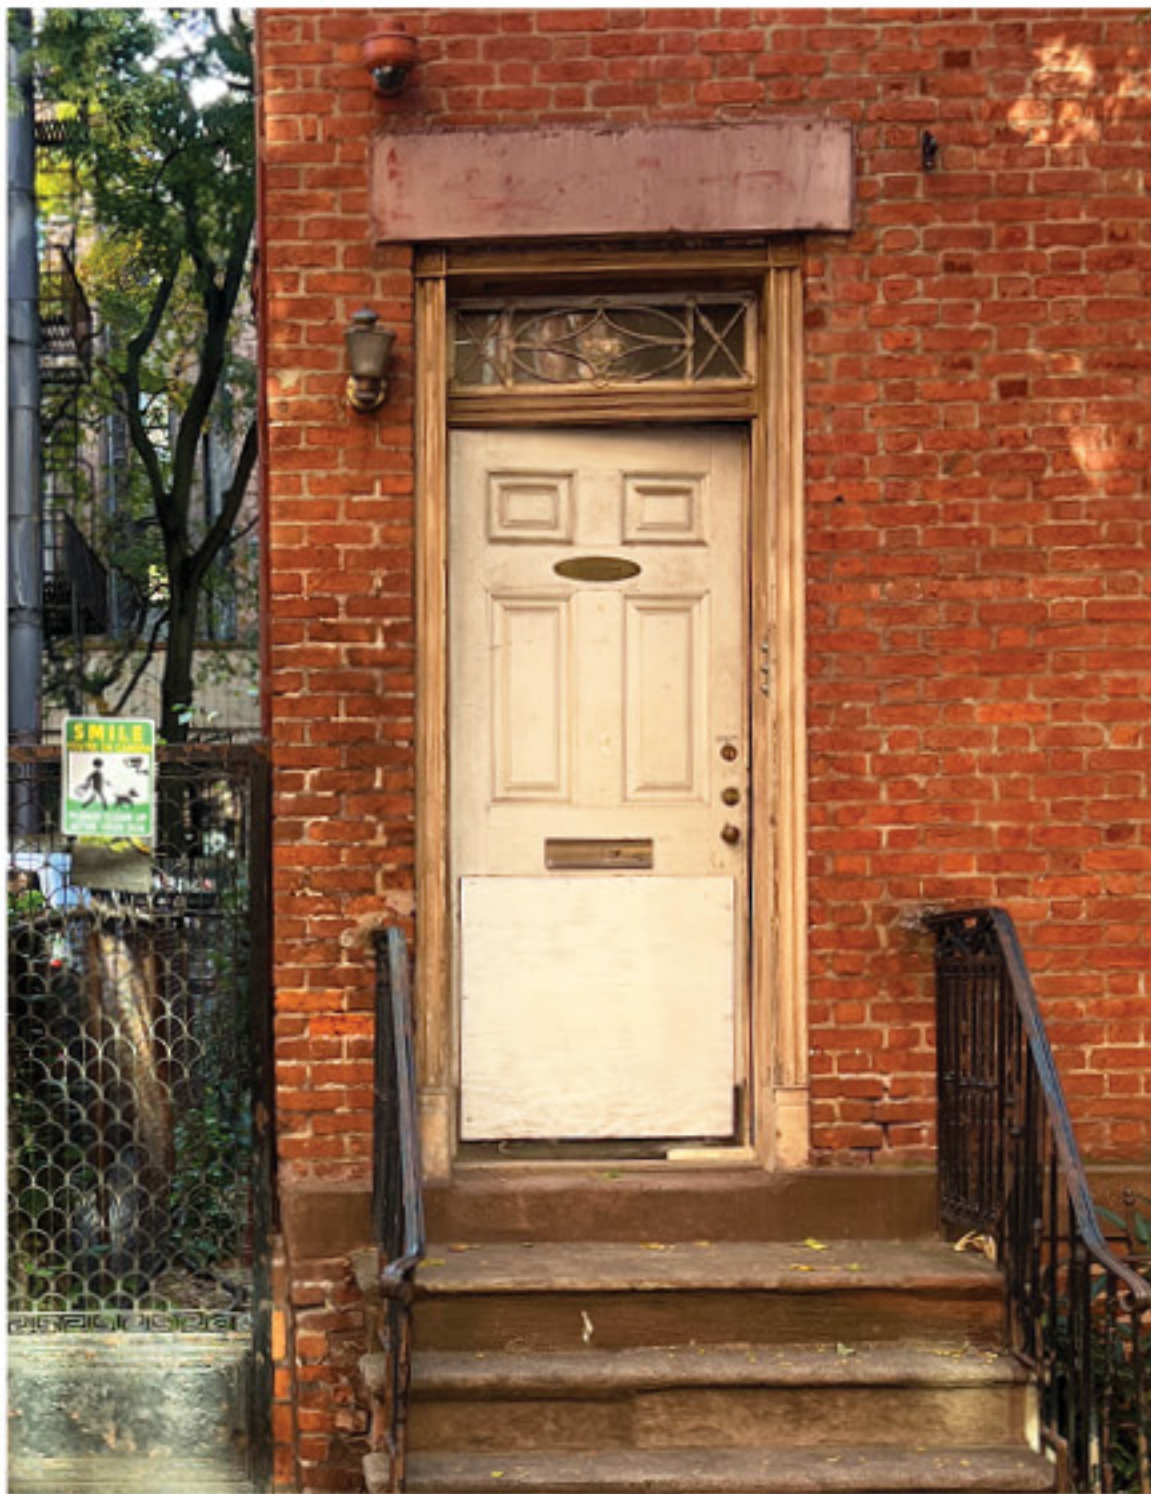
Existing Conditions: Facade Features

Original, historic door surrounds and transoms to be preserved at both addresses.

Non-original doors to be replaced with new doors to match historic doors w/ lites as shown in the 1940's tax photos.

Original, historic cornices and wrought-iron railings to be preserved.

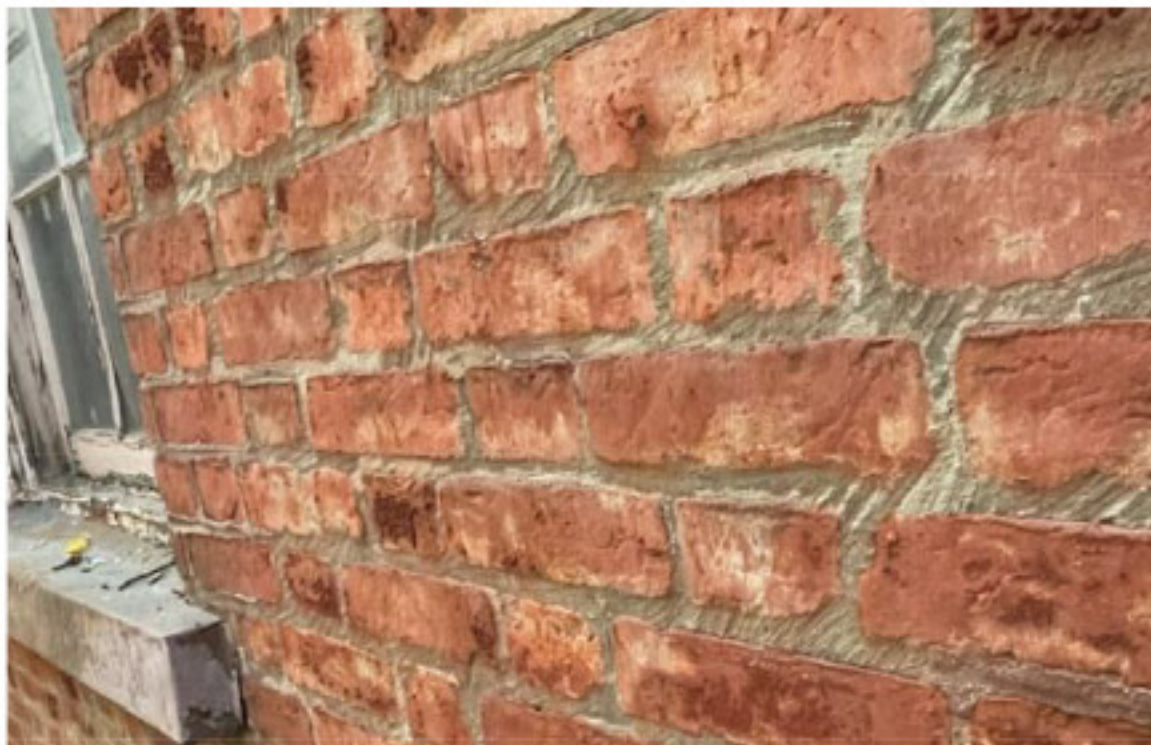
Mechanically Scraped Bricks

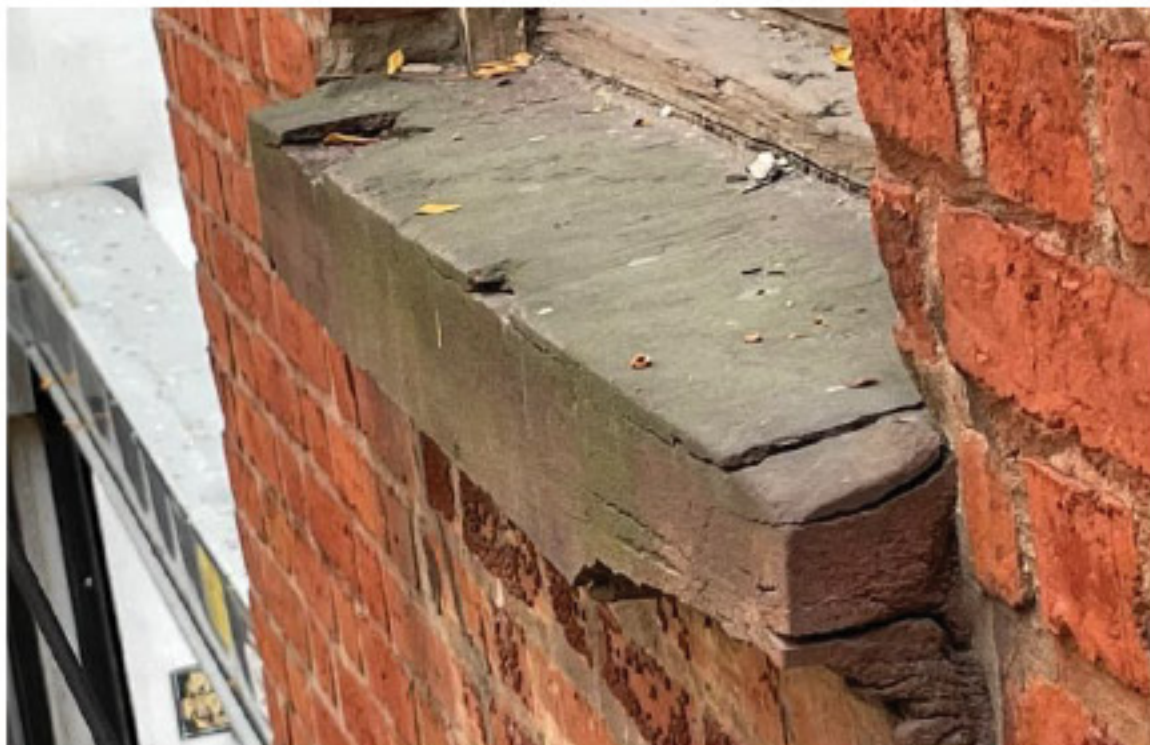
Stone Sill Deterioration

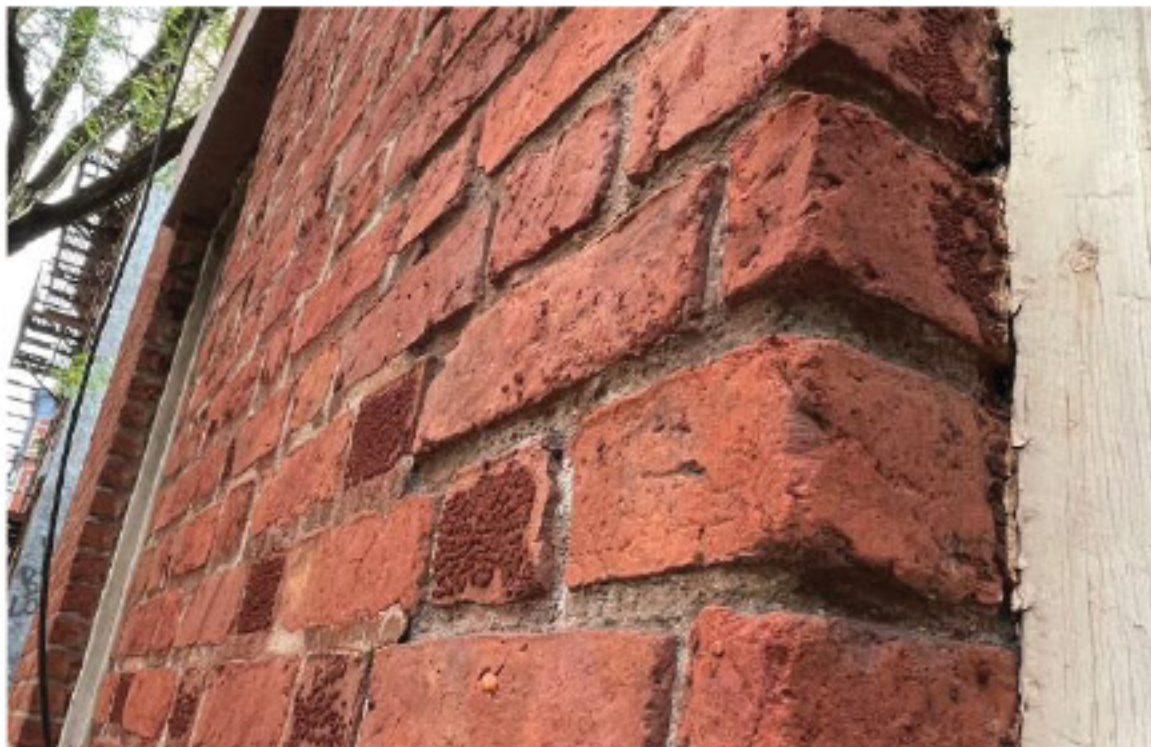
Mortar Erosion

R100 RAKE OUT ALL LOOSE MORTAR AND REPOINT 100% OF JOINTS. TOOL MORTAR. MATCH EXISTING HISTORIC MORTAR TO ORIGINAL MORTAR LAB COMPOSITION RESULTS.

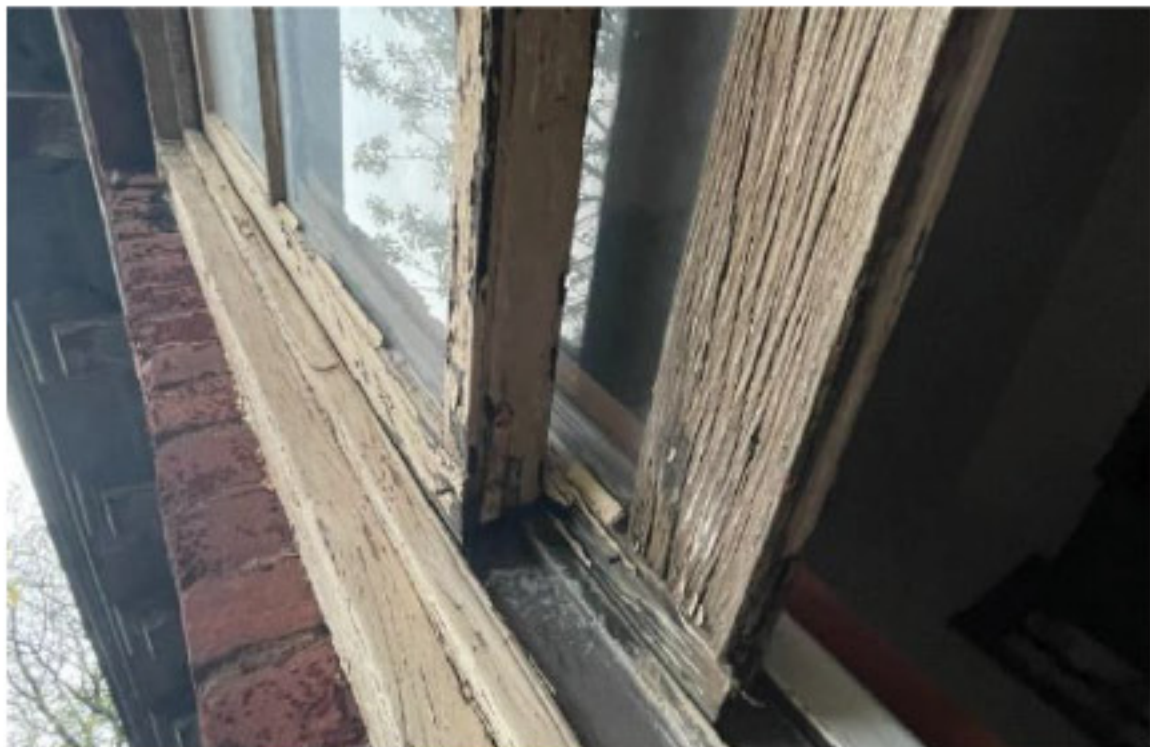
Severe Window Frame Deterioration

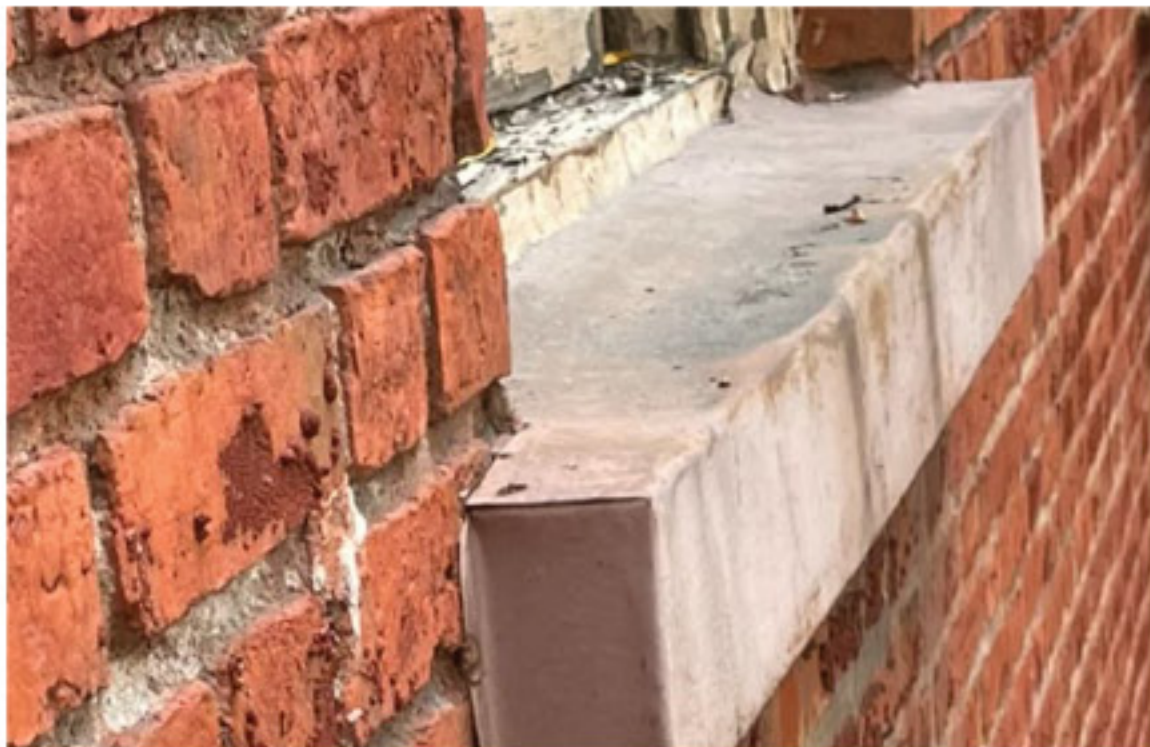
Sill Covered in Break Metal

MC REMOVE EXISTING METAL COPINGS OVER BROWNSTONE SILLS AND LINTELS. PROVIDE ACCESS FOR ARCHITECT TO ASSESS UNDERLYING BROWNSTONE CONDITIONS. REPLACE WITH NEW PRECAST UNITS TO MATCH EXISTING LINTEL/SILLS IN COLOR, LAYOUT & SIZE.
	CB REMOVE AND REPLACE CRACKED BRICK UNITS. KEY NEW UNITS INTO EXISTING. NEW BRICK TO MATCH EXISTING IN SIZE, COLOR, AND LAYOUT. PROVIDE SAMPLES FOR ARCHITECT APPROVAL.
	SL PATCH SPALLED BROWNSTONE LINTEL/SILL USING COMPATIBLE REPAIR MORTAR. PROVIDE ACCESS FOR ARCHITECT TO ASSES BROWNSTONE CONDITIONS AFTER AREA HAS BEEN CLEARED OF SPALLED AREAS AND IS BEING PREPARED FOR APPLICATION OF PATCHING MATERIAL.
	RPJ REPOINT BRICK MORTAR JOINTS AT JAMBS DOOR MASONRY OPENINGS.
	RP REPOINT ISOLATED OPEN MORTAR JOINTS.

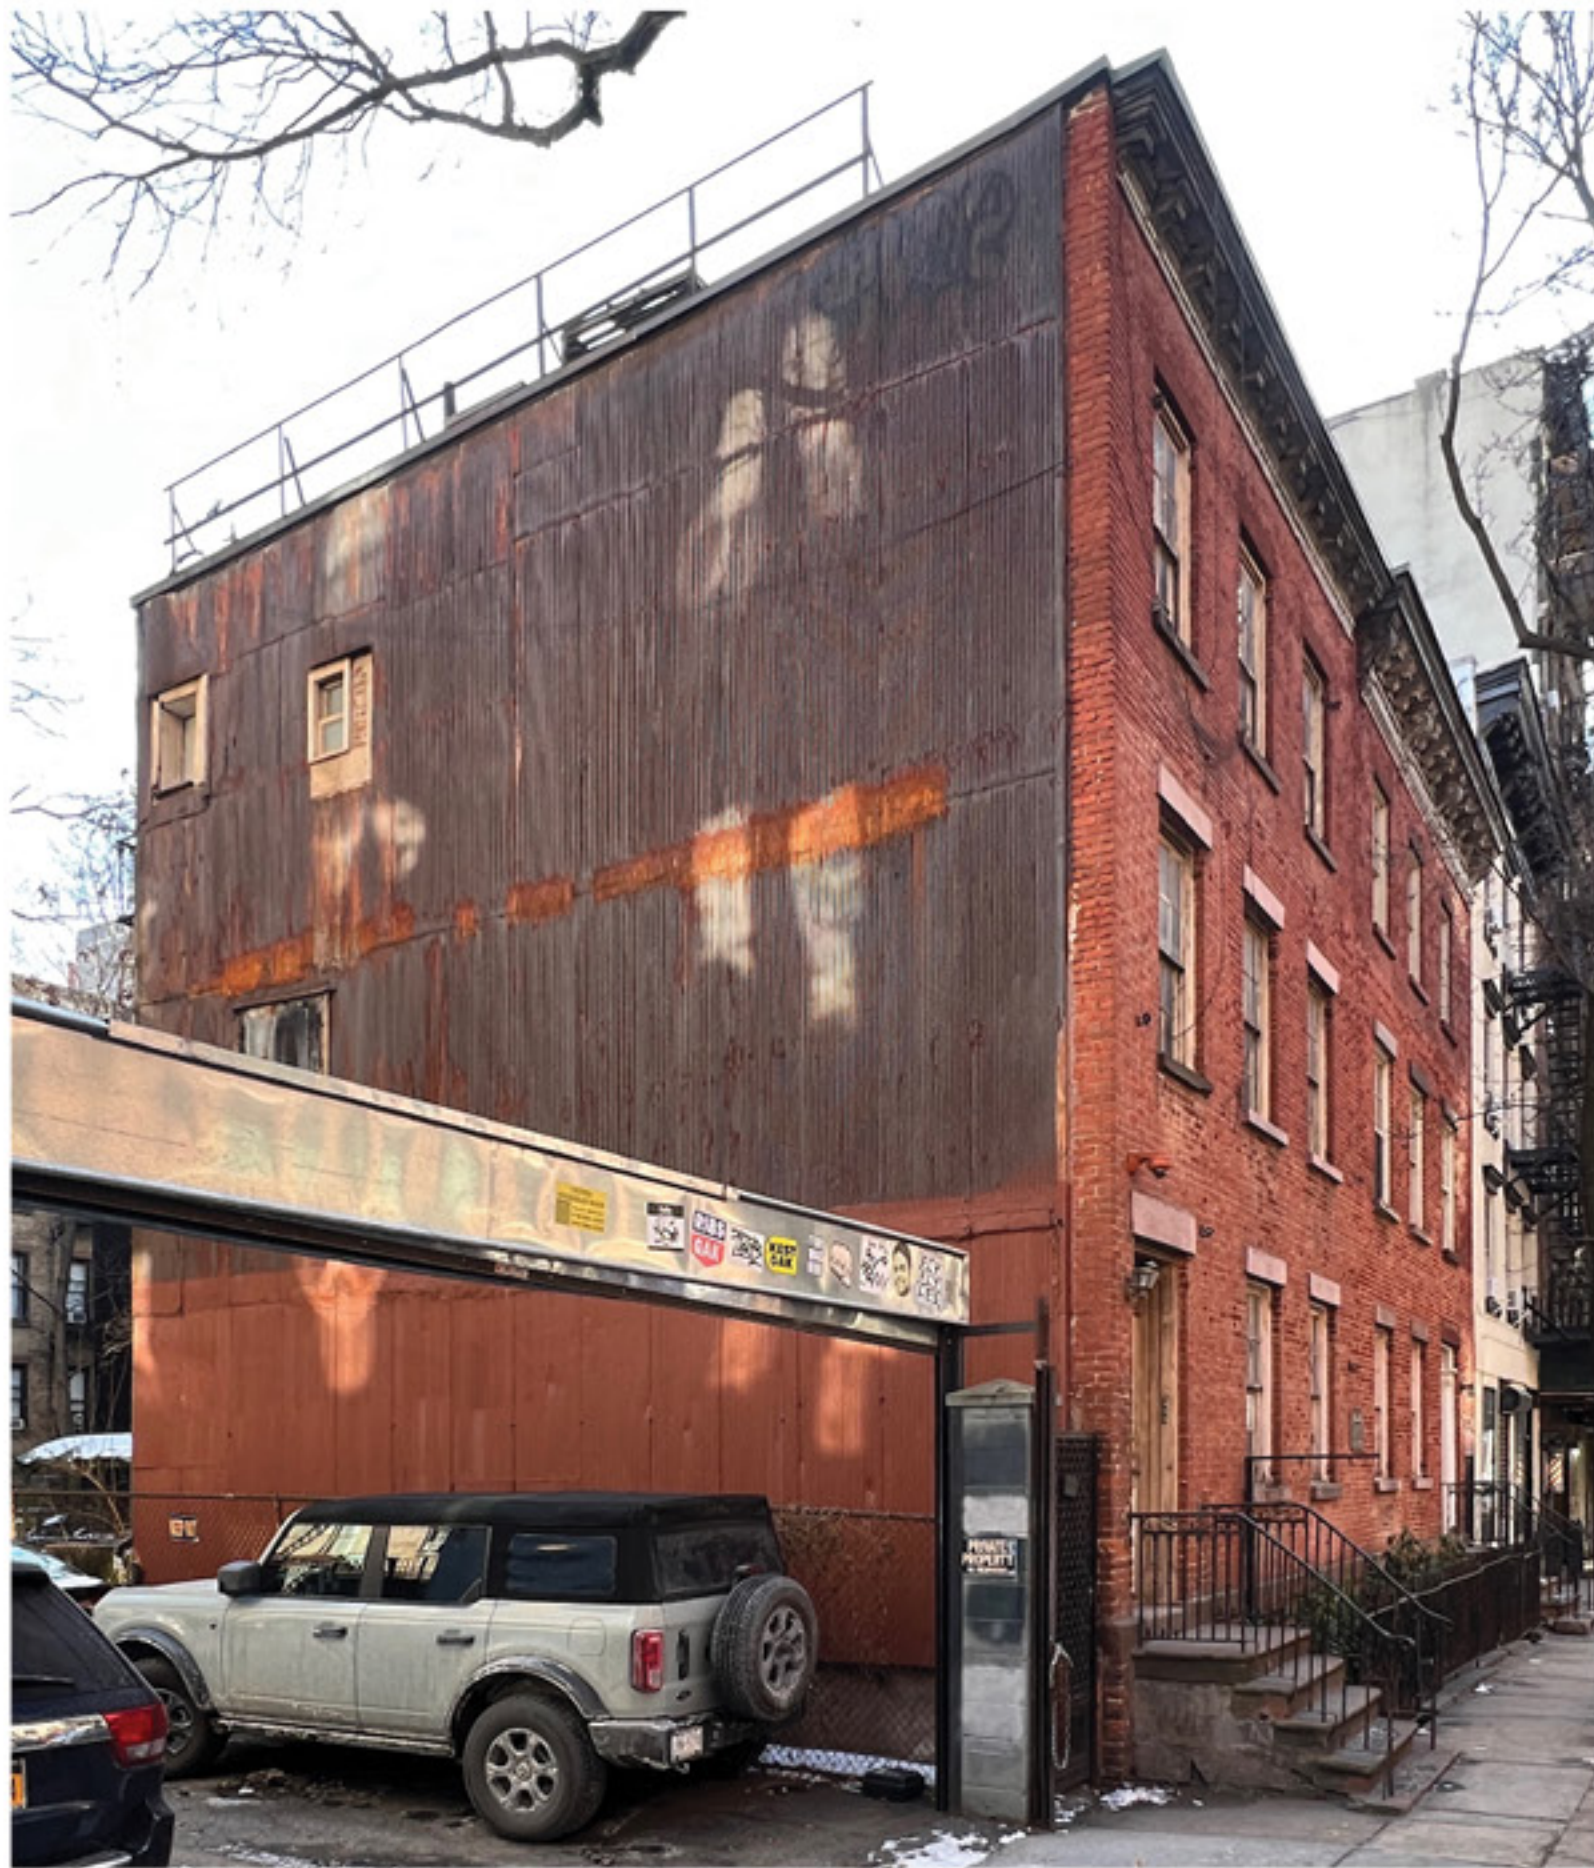
85 Sullivan: Existing Disrepair

85 Sullivan Street North Facade
Current photograph, deteriorated metal cladding, installed in 1930s

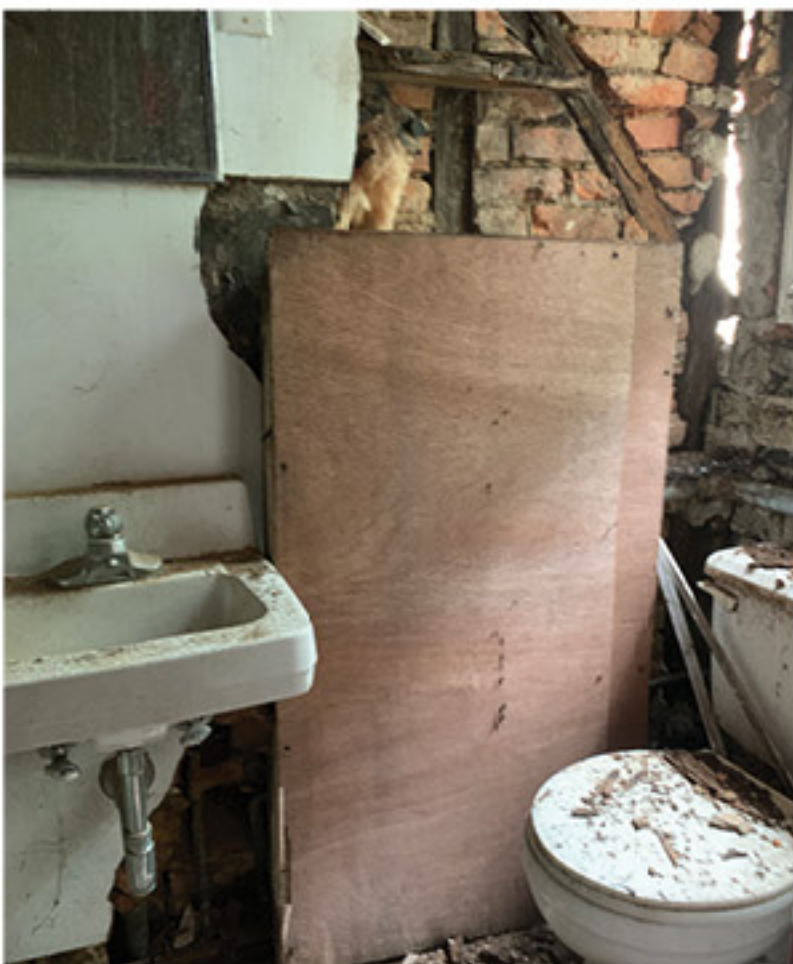
Interior deterioration due to weather infiltration at open exterior corner

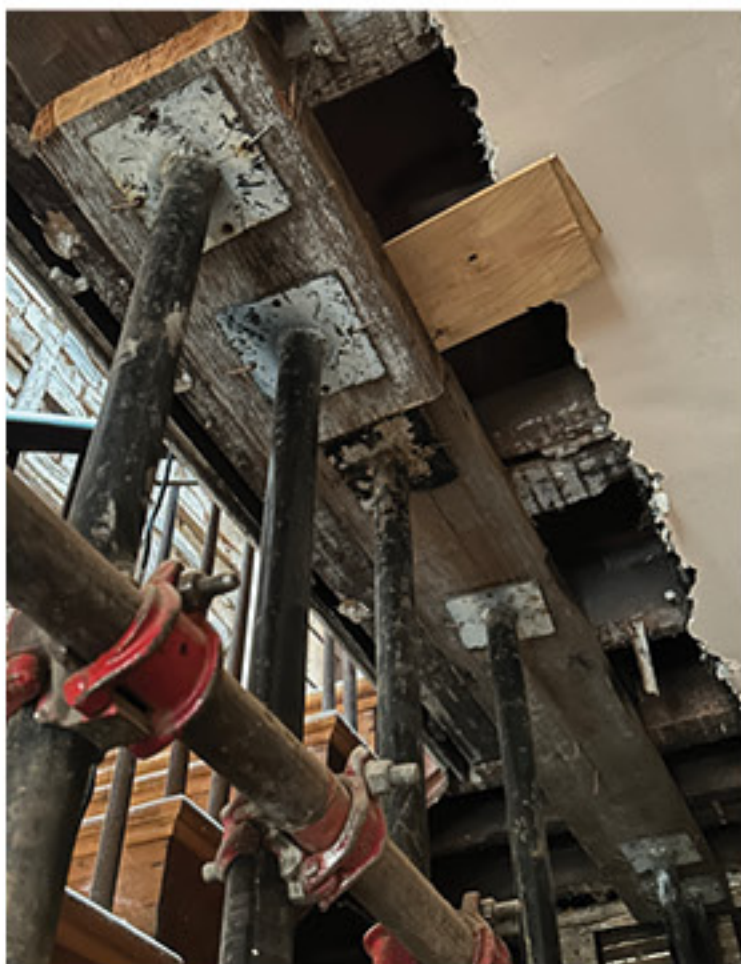
Structural shoring, installed in 2009 to prevent building collapse

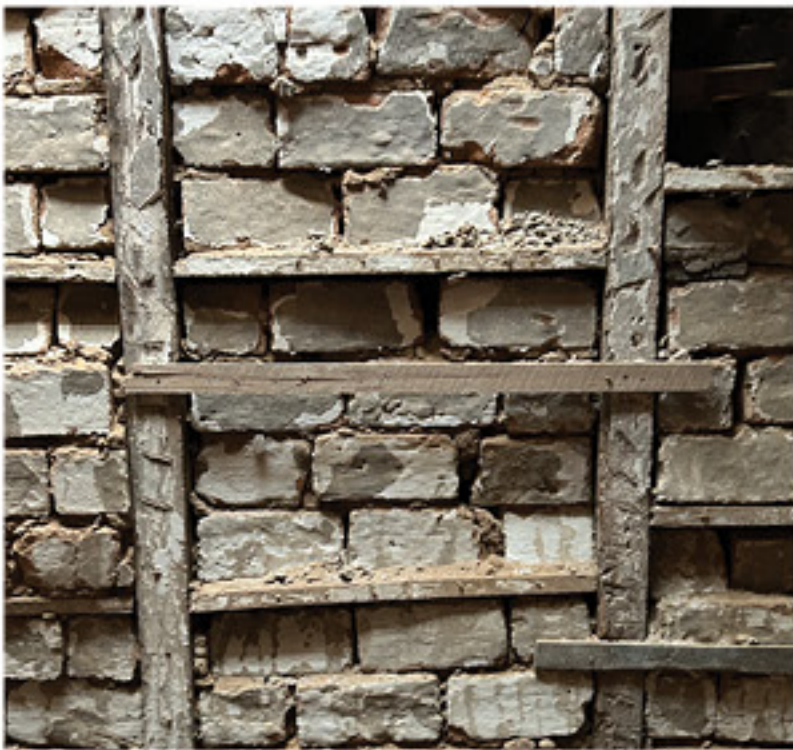
Decay of brick nogging wall,
including loose brick and rot at
original structural timbers

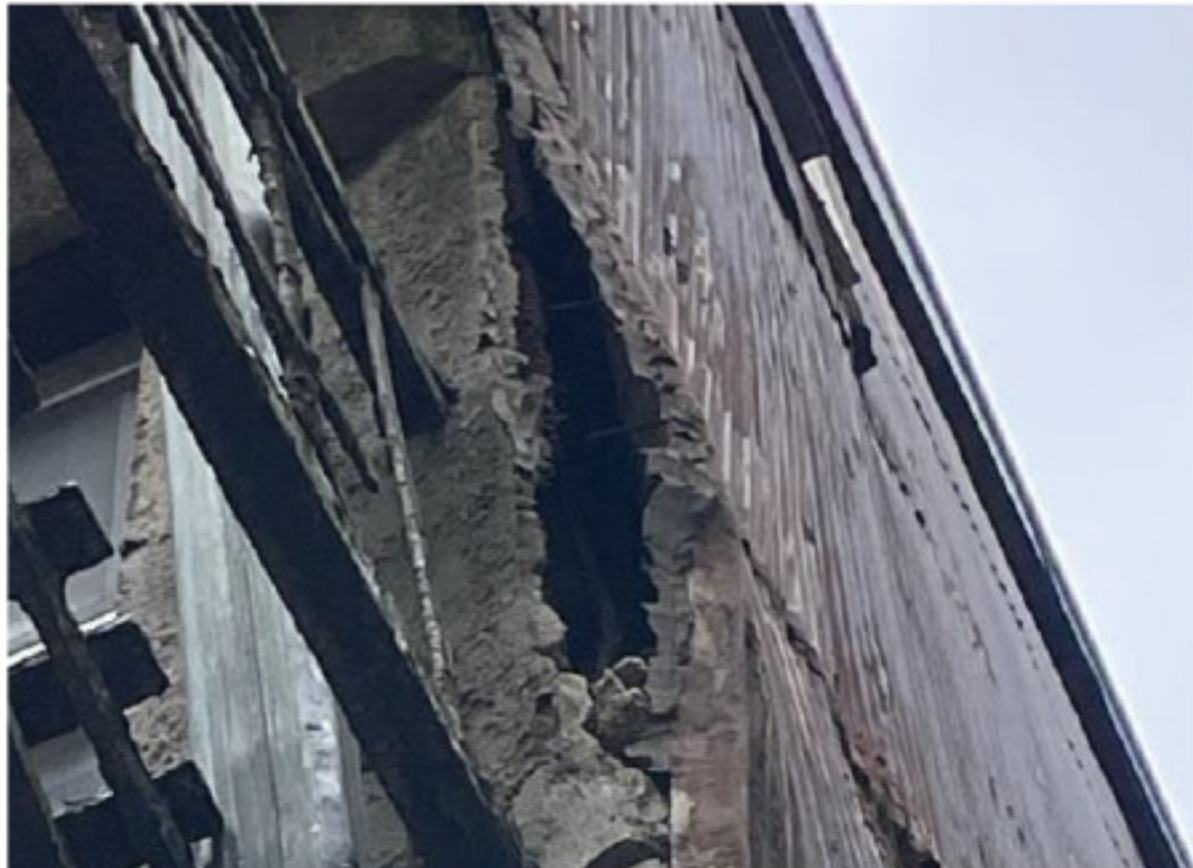
Buckling Wall
Separation of the north and east wall,
source of considerable water infiltration

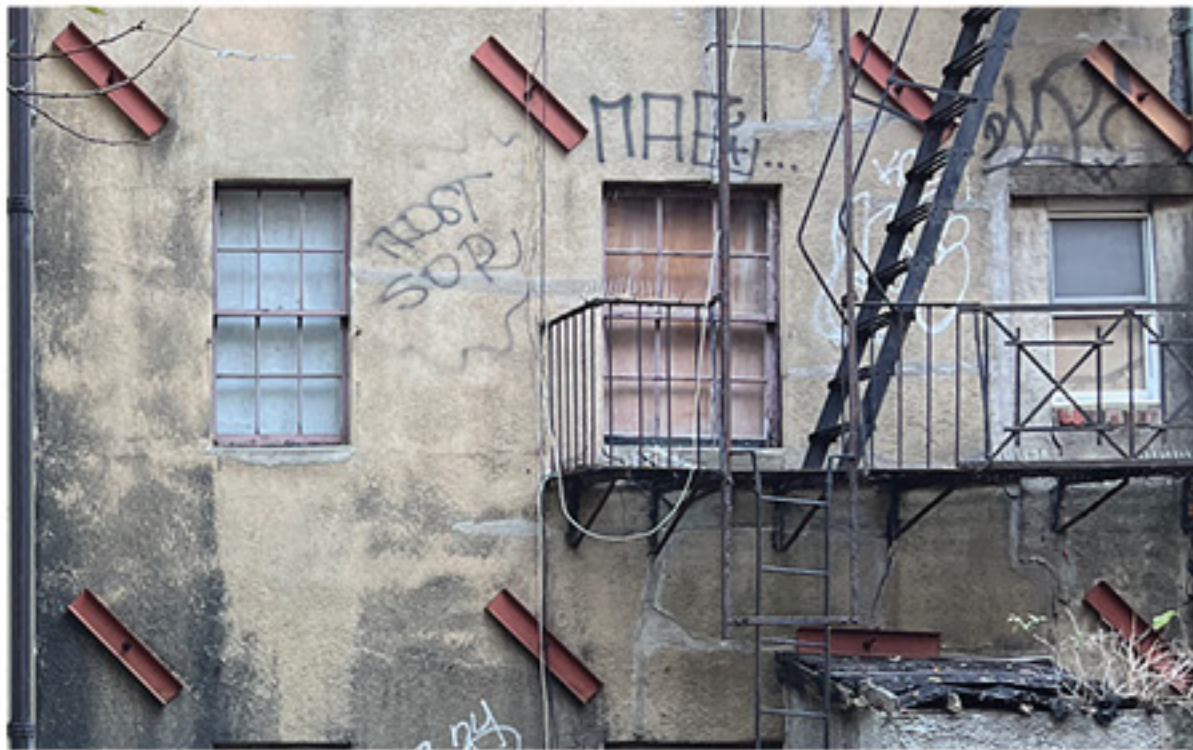
Exposed Structural Tie-Backs
Installed in 2009 to help stabilize the building
and prevent further separation of the facade
